Re: Property Condition Assessment Report for *Palos Verdes Estates City Hall Buildings and Parking Structure and Seismic Evaluation Palos Verdes Estates, California 90274 Walker Consultants Project No. 37-009696.01*

## Property Condition Assessment Report

Palos Verdes Estates City Hall  
Buildings and Parking Structure and Seismic Evaluation  
Palos Verdes Estates, California  
Walker Project No. 37-009696.01  
November 30, 2023

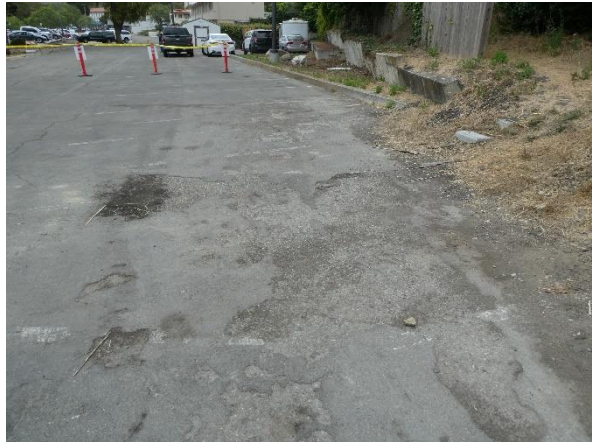
The asphalt paving is in generally fair to locally poor condition with linear cracks at the drive lanes and raveling at select areas. Cracksealing, sealcoating, and restriping of pavement with limited full-depth patching is anticipated during the evaluation period.

Photo 2 - Remote Lot: Select areas of the asphaltic concrete pavement are raveled.

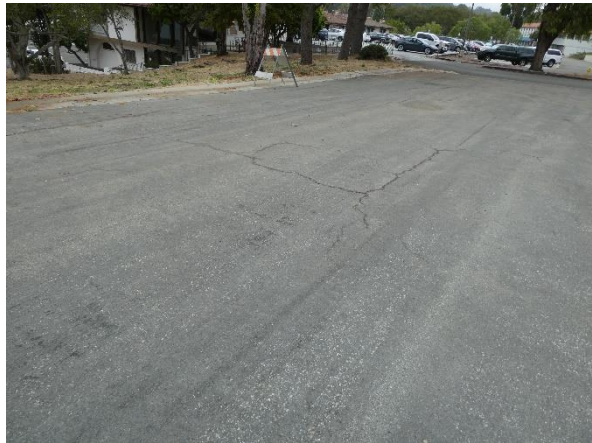
Photo 4 - Remote Lot: Cracks at drive lanes.

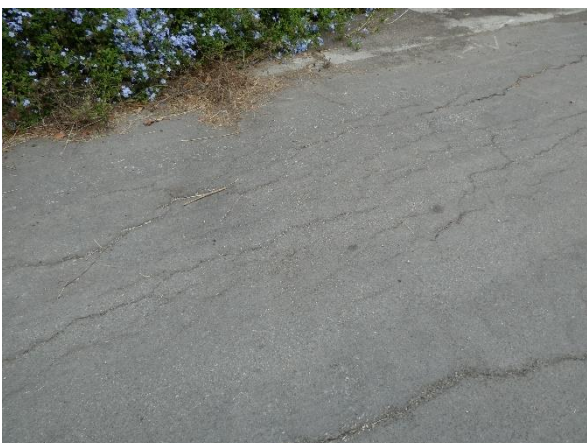
Photo 5 - Remote Lot: Cracks at drive lanes.

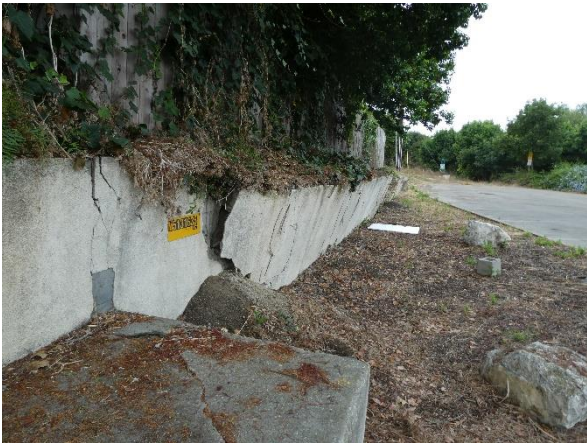
The cast-in-place concrete retaining wall near the southwest site boundary ranges in height up to 8 feet and is leaning out-of-vertical plumb. An immediate allowance has been included to evaluate the conditions and recommend appropriate repair recommendations by a licensed professional engineer in the State of California. The investigation costs do not include any contingency for repairs identified by the investigation.

Photo 9 - Rotation and retaining wall failure near the  
southwest site boundary.

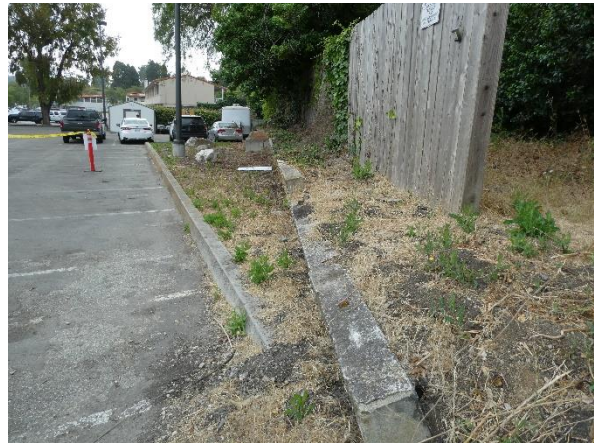
Photo 10 - Retaining wall rotation near the southwest site  
boundary.

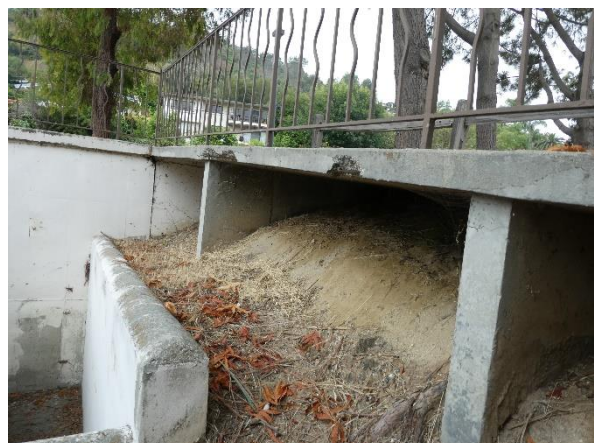
Photo 12 - Damaged concrete ramp and erosion at the  
under-ramp locations.

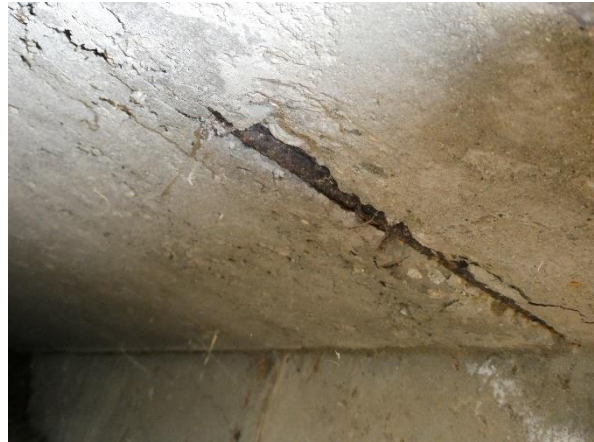
Photo 14 - Exposed rebar at the underside of the site ramp.

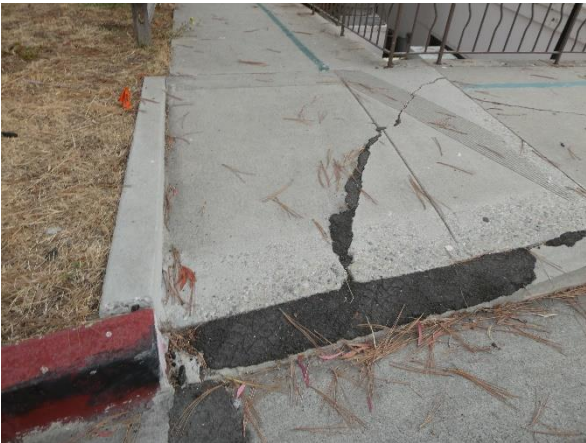
Photo 15 - Concrete repair needed at the ramp landing.

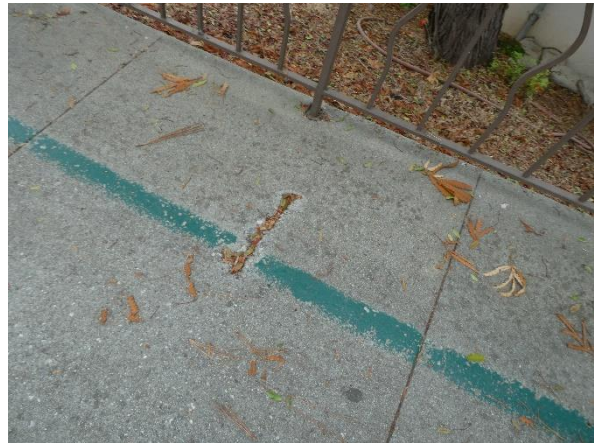
Photo 16 - Damaged concrete at the site ramp.

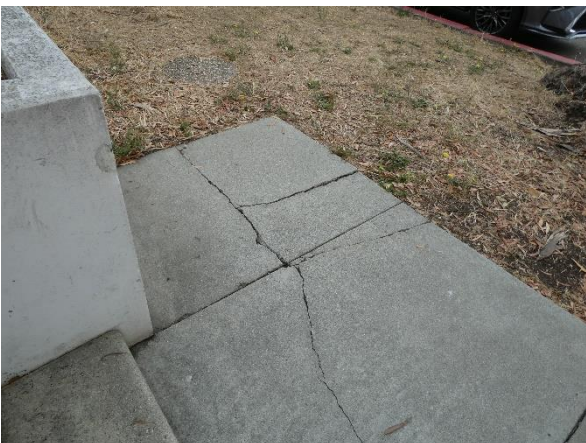
Photo 17 - Missing handrail and cracked concrete pavement near the cast-in-place site stairs adjacent to Building 340.

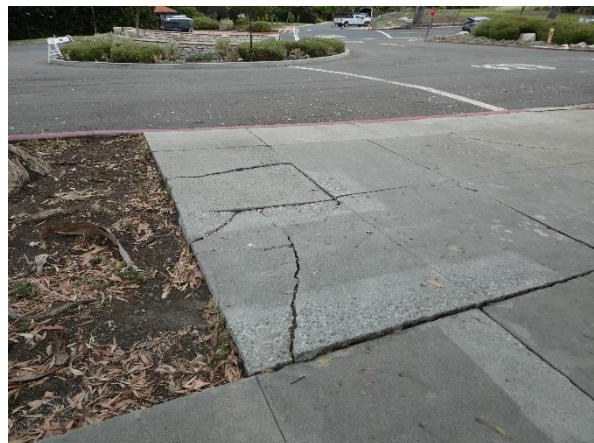
At the north building elevations, several uneven walking surfaces at the concrete paved surfaces are trip hazards, and an allowance to address is included during the reserve term as an immediate repair.

Photo 18 - Cracked and uneven concrete-paved walking surfaces near the north site boundary.

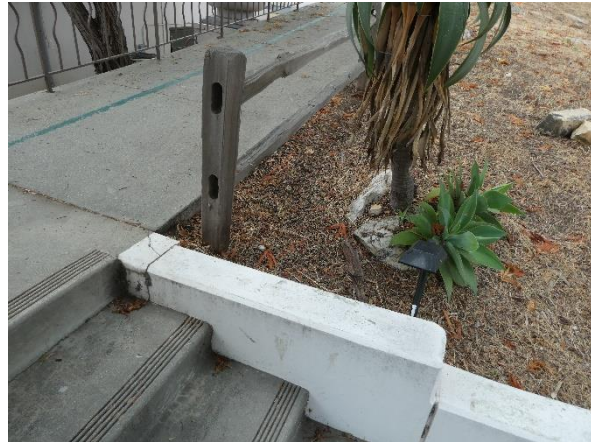
Photo 20 - Handrails not provided at the site stairs.

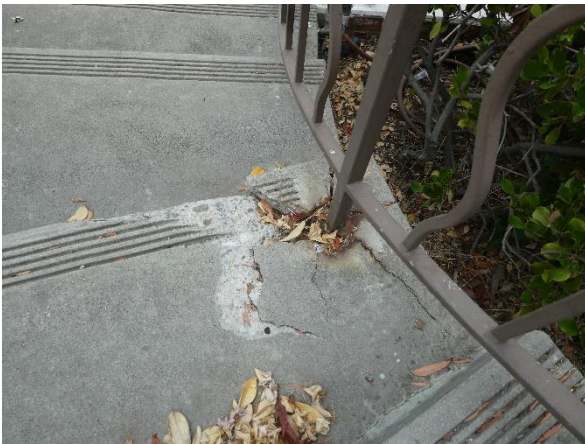
Photo 21 - Spalled concrete at guardrail post anchors.

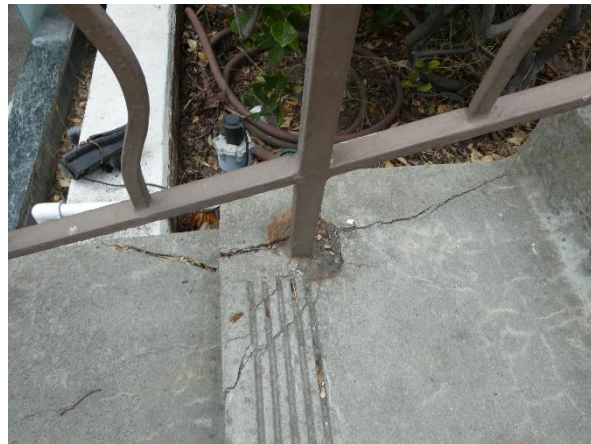
Photo 22 - Cracked concrete at guardrail post anchors.

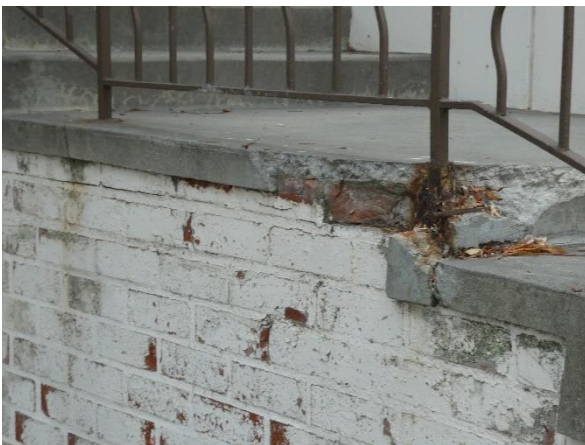
Photo 23 - Spalled concrete at guardrail post anchors.

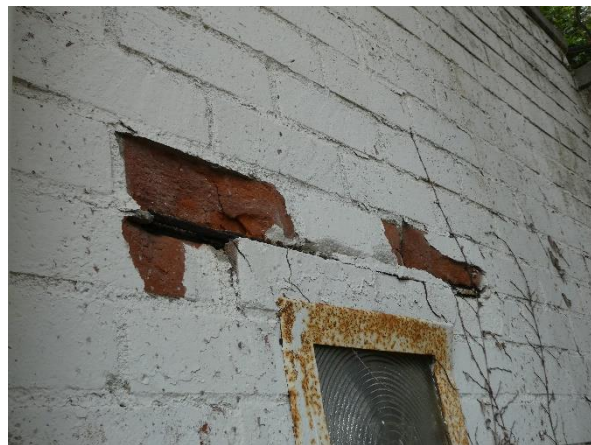
The masonry veneer at the retaining wall adjacent to the water feature is delaminated at select locations. Delaminated areas should be repaired and sealed, and the retaining wall routinely monitored

Photo 24 - Select finishes at the masonry veneer retaining wall are spalled, and painted finishes are peeled.

for further signs of delamination as part of routine maintenance. A cost for repair is not included during the reserve term.

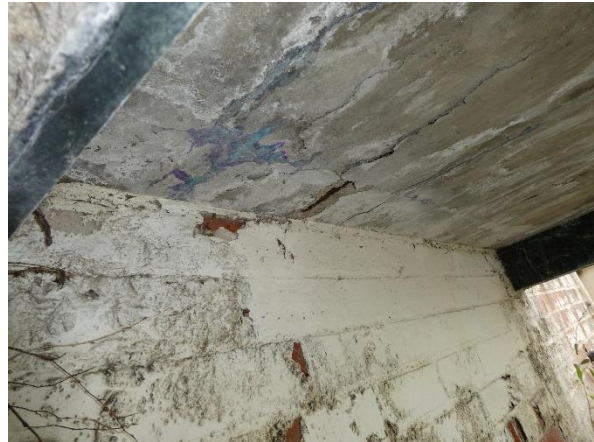
Per the Designated Site Contact, the water feature at the west building elevation has not been operational for several years and the front elevation is damaged. At the underside of the water feature, the concrete is cracked and spalled throughout, and rebar exposed at select locations. An allowance to evaluate the conditions and recommend appropriate repair recommendations is included during the reserve term as an immediate repair.

Photo 28 - Condition of cast-in-place concrete at the water feature.

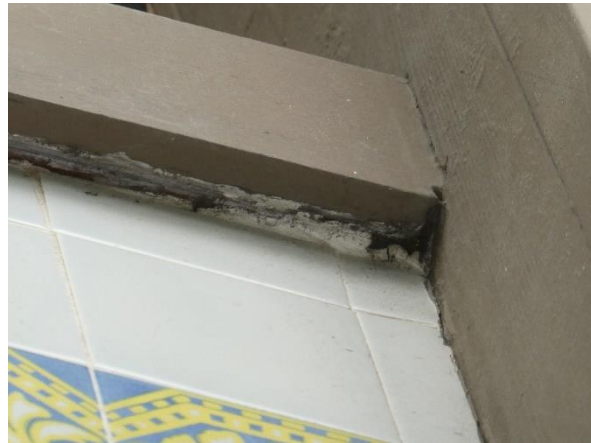
Photo 34 - Building 320: Deteriorated sealant.

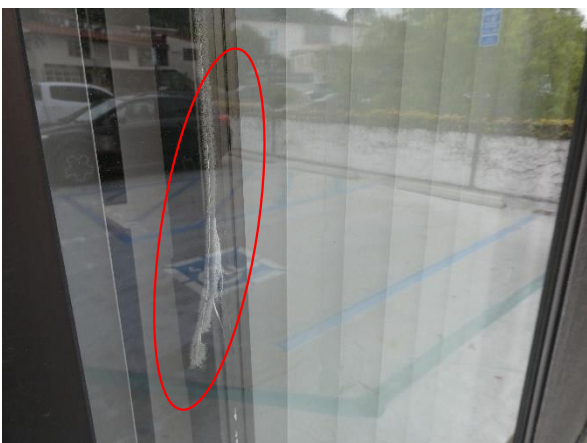
Photo 35 - Building 320: Damaged weatherstripping at window.

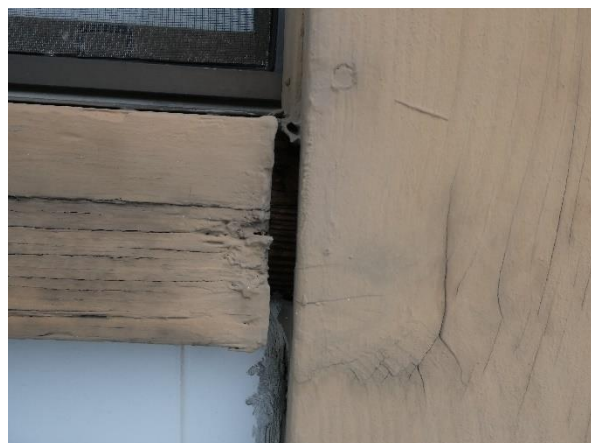
Photo 36 - Building 320: Condition of painted wood trim and missing joint sealant.

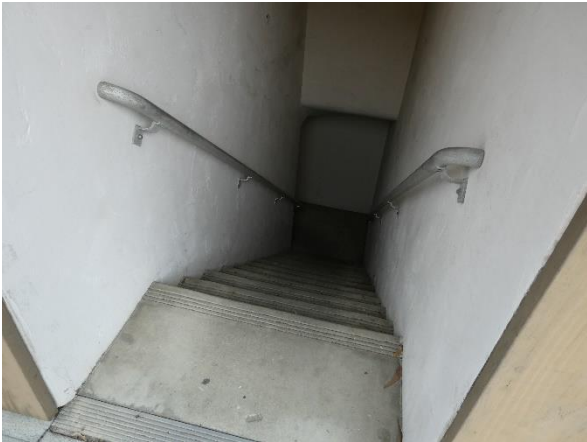
Photo 37 - Building 320: Handrail extensions not provided at the building exterior stair.

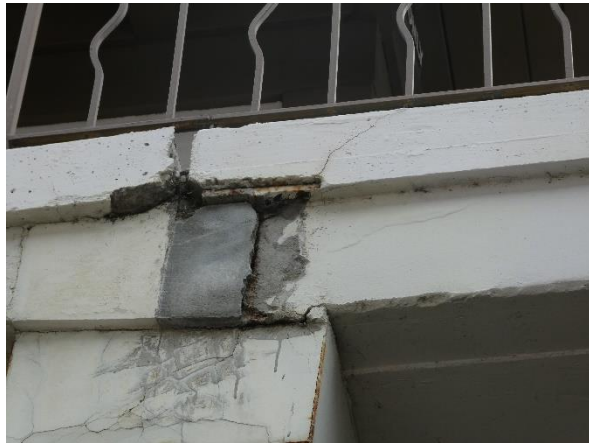
Photo 40 - Spalled concrete at the elevated walkway.

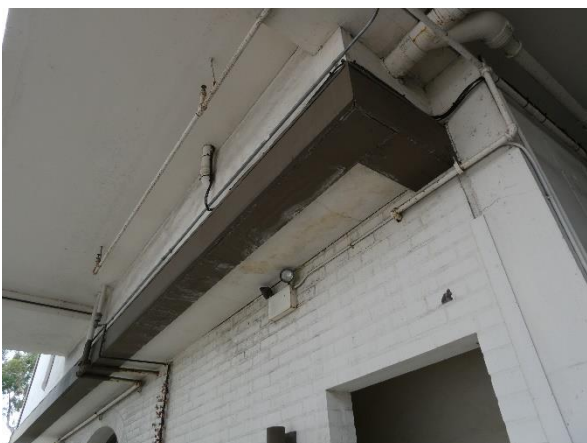
At Building 320, water intrusion was noted at the underside of the elevated walkway as evidenced by water-stained stucco and wood trim. It is not apparent if the source of water intrusion originates from a drain leader, damage quarry tile flooring, or a combination of the beforementioned. The source of water intrusion should be identified and repaired as an immediate repair to prevent any additional damage to the finishes and potential damage to the structure.

Photo 41 - Elevated walkway: Evidence of water intrusion.

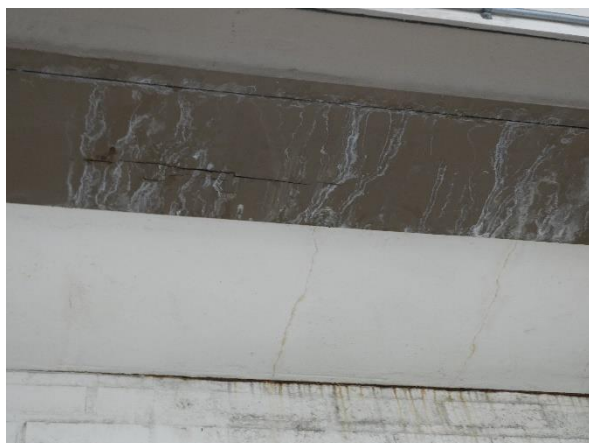
Photo 42 - Close-up of staining and damaged wood trim from the previous photo.

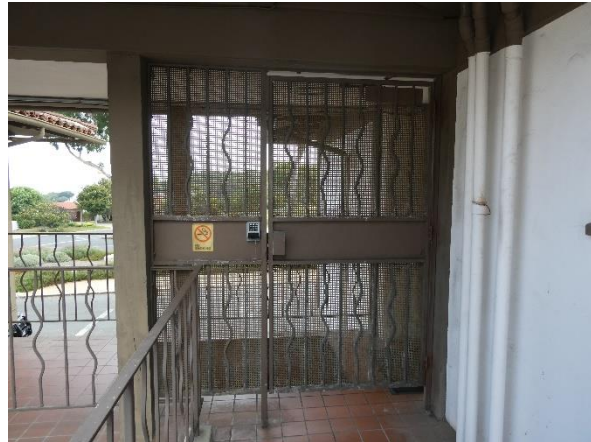
At the elevated walkway, painted metal finishes at the access door are peeled and corroded, and allowance to refinish is included during the evaluation period.

Photo 44 - Elevated walkway: Painted finishes are deteriorated and corroded at the access door.

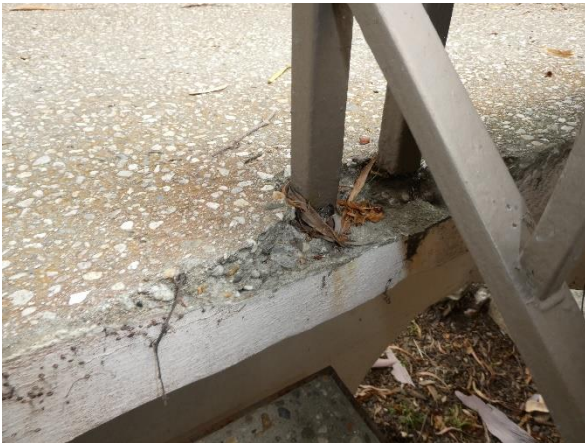
Photo 45 - Building 320: Spalled concrete at guardrail post anchor.

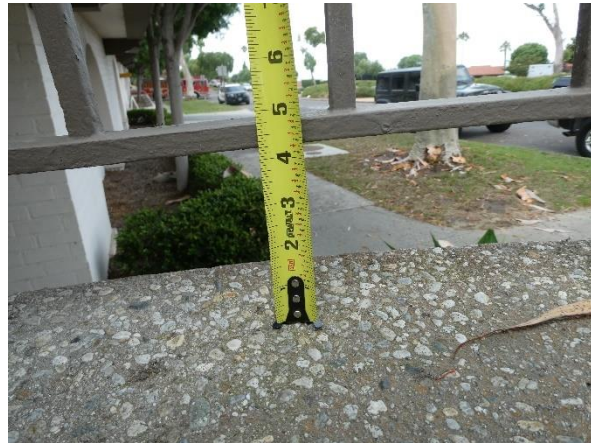
Photo 46 - Building 320: The bottom of the guardrail to the finish floor exceeds 4 inches.

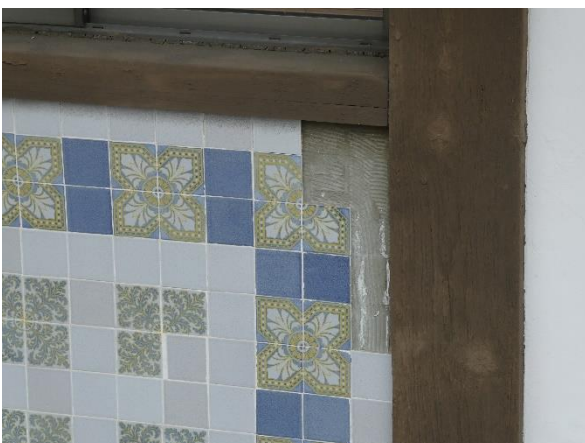
Photo 53 - Building 340: Missing ceramic tiles.

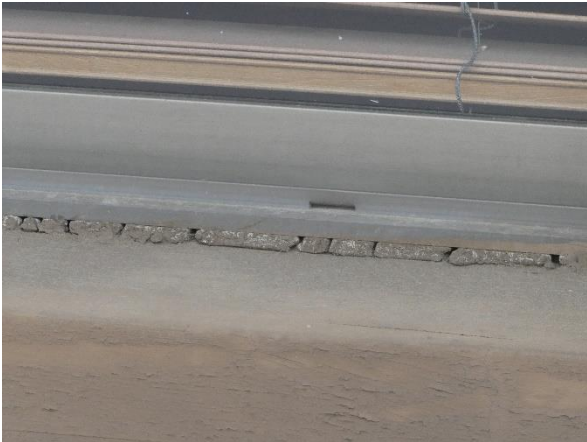
Photo 55 - Building 340: Deteriorated grout between the window frame and wood trim.

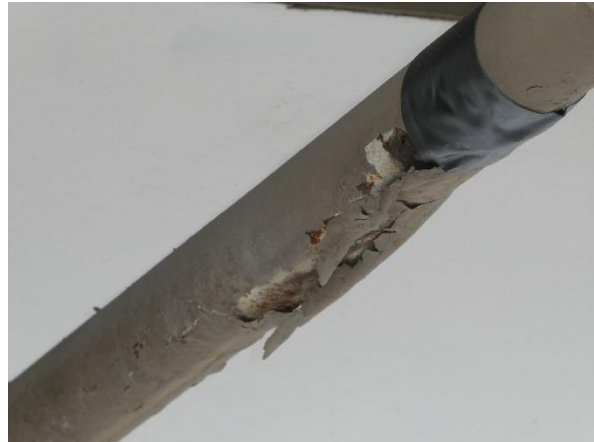
Photo 56 - Building 340: Select painted metal surfaces are peeled.

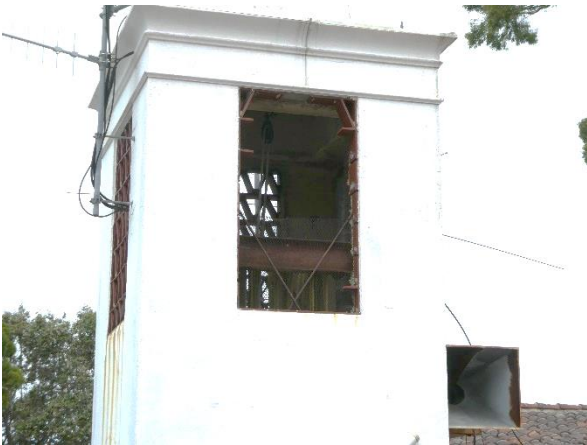
Photo 57 - Building 340: Missing tiles at the tower.

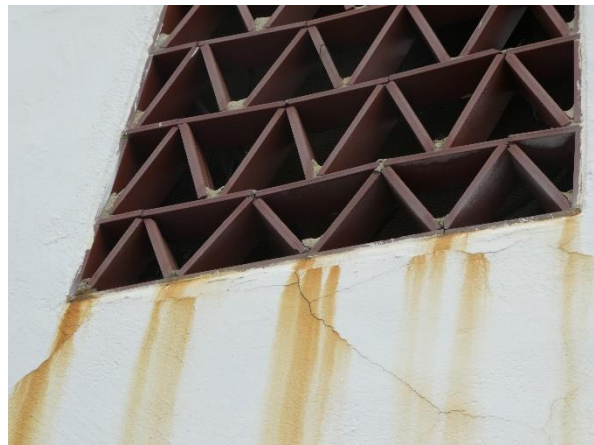
Photo 58 - Building 340: Surface stains and cracking at the tower.

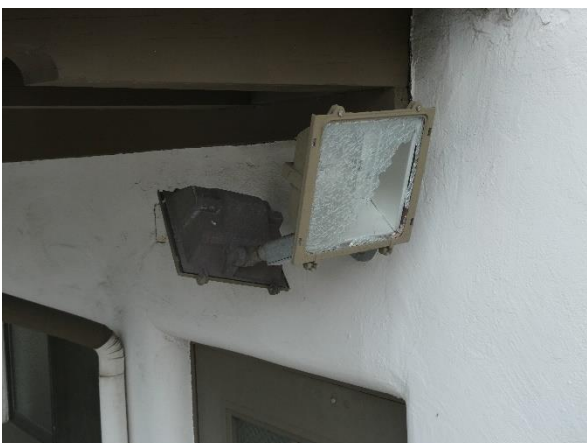
At Building 340, a surface-mounted light fixture is damaged and should be repaired as part of routine maintenance. A cost for repair is not included.

Photo 59 - Building 340: Damage surface-mounted lighting.

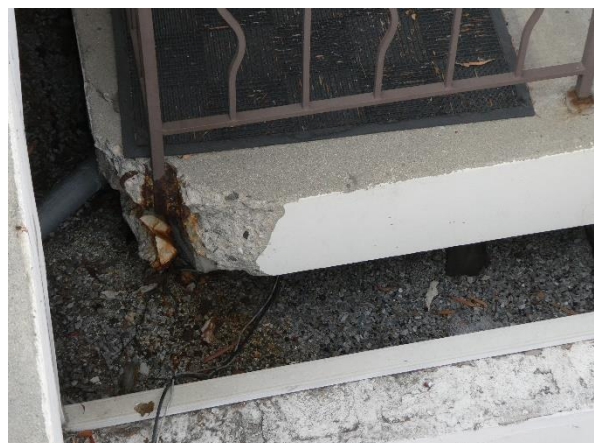
Photo 60 - Building 340: Damaged walkway concrete pavement near City Hall **2022**

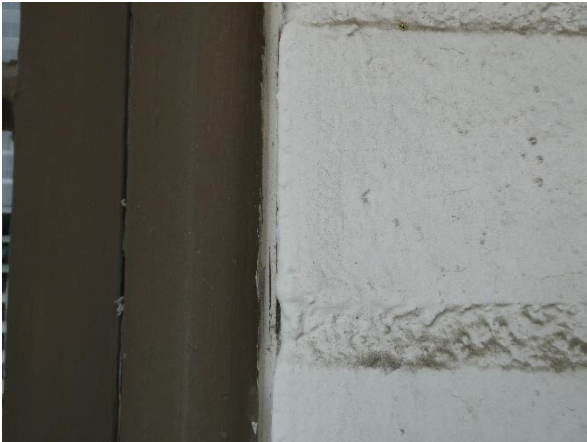
Photo 61 - Building 340: Sealant at window penetrations is deteriorated.

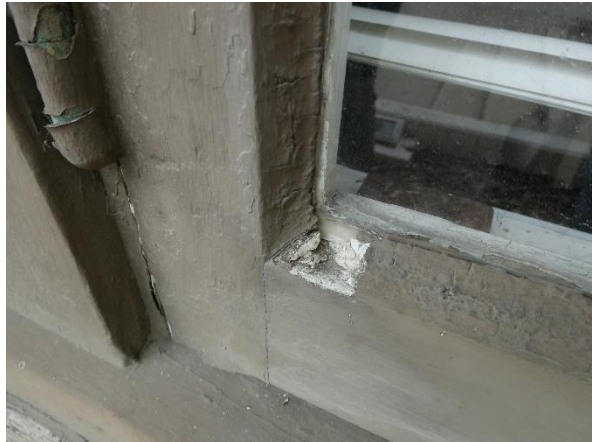
Photo 62 - Building 340: Glazing putty at select windows is missing.

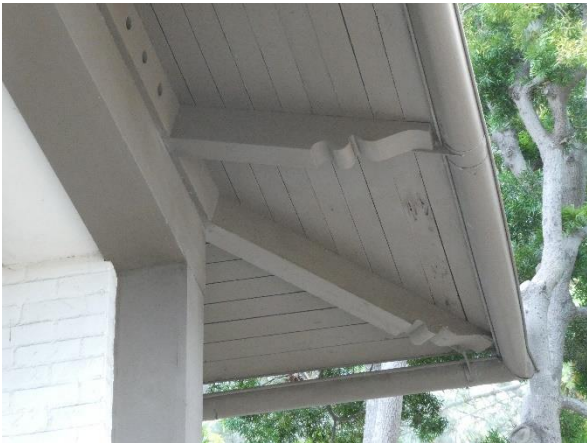
Photo 63 - Building 340: Damaged wood trim at overhang.

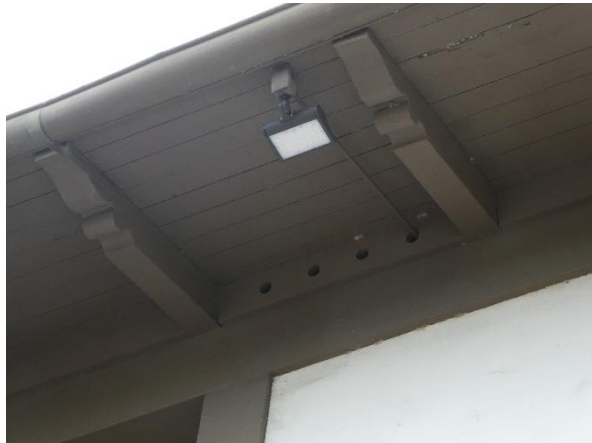
Photo 64 - Building 340: Damaged wood trim and overhang.

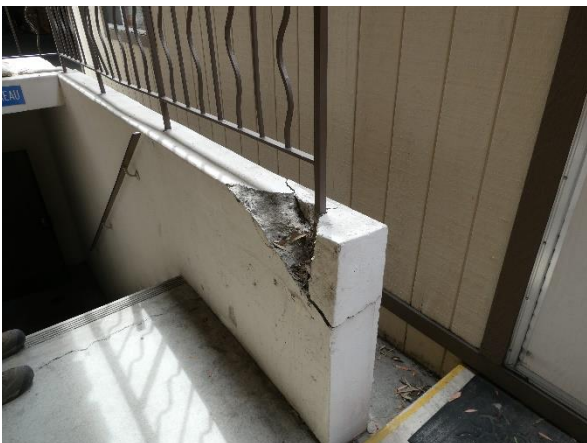
Photo 65 - Building 340 (Detective Bureau): Damage to the cast-in-place retaining wall.

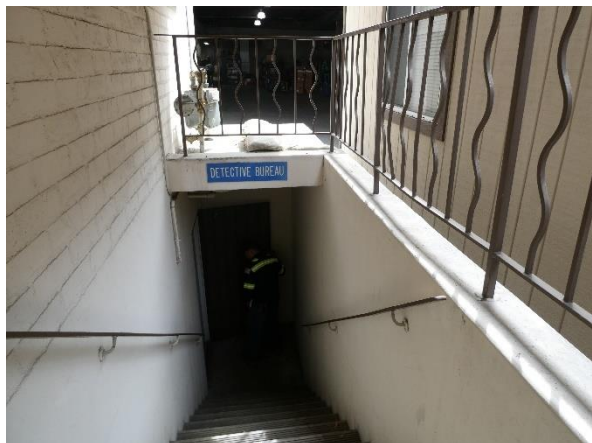
Photo 66 - Building 340 (Detective Bureau): Handrail extensions not provided at the stairs.

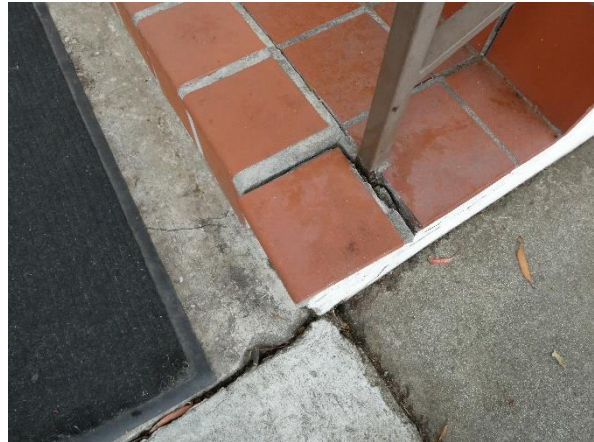
Photo 68 - Building 340 (Police Department): Damaged tile at guardrail post anchor.

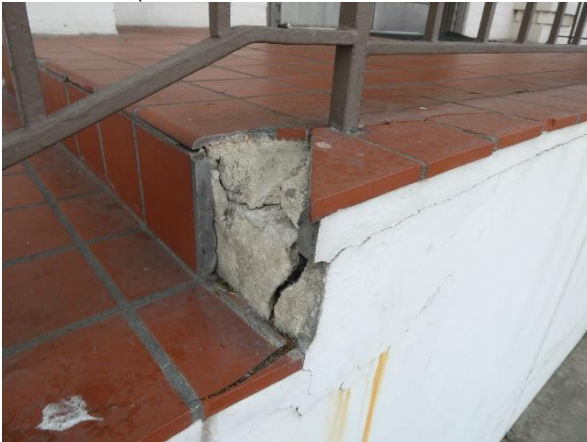
Photo 69 - Building 340 (Police Department): Damaged tile and concrete at guardrail post anchor.

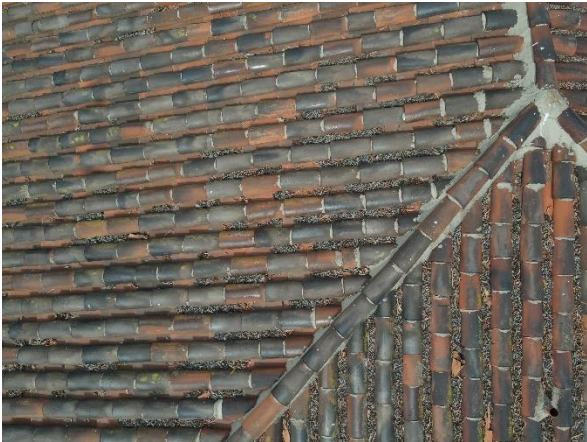
The terra-cotta clay tile roofs are in fair to locally poor condition with exposed underlayment, and missing fasteners and discolored tiles at select locations. Cracks were noted at clay tile mortar joints intersections and delaminated tiles were observed throughout the field of the roofs. Approximately 35% of the clay tiles are damaged (delaminated, discolored, missing, or broken). No information was provided regarding the replacement of the tile roof underlayment. To replace underlayment, all tiles need to be removed/replaced. Based on age and EUL, underlayment replacement is anticipated during the reserve term. Replacement of damaged and missing terra-cotta tiles is anticipated during the reserve term.

Photo 73 - Building 320: Multiple cracks in mortar joints at clay tile intersections.

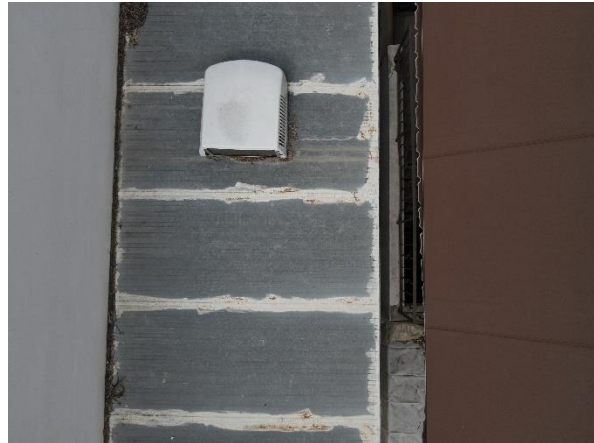
Photo 76 - Corroded sheet metal at the freestanding building adjacent to Building 340.

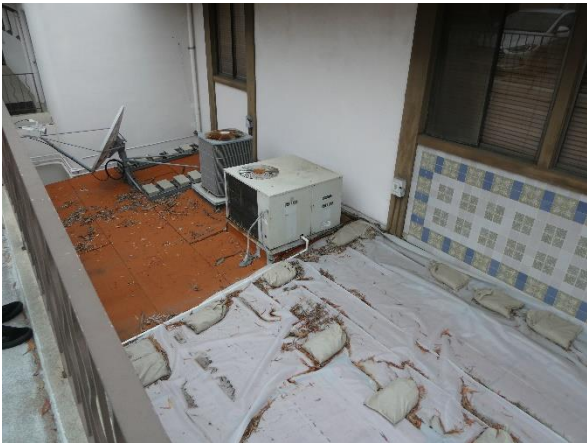
The modified bitumen and built-up roof systems are in fair to poor condition, and their ages are unknown. Plastic sheeting secured by sandbags covers a portion of the modified bitumen roof at the south building elevation. Replacement of the modified bitumen and built-up roof system are anticipated during the reserve term based on observed conditions and expected useful service life. Where provided, built-up roofs should be replaced with a modified bitumen roof system.

Photo 87 - Building 340: Condition of modified bitumen roof systems at the South building elevation.

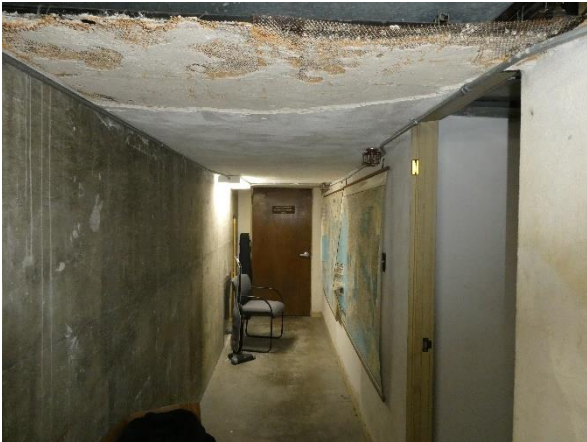
Photo 103 - Building 320: Damaged corridor plaster ceiling finishes.

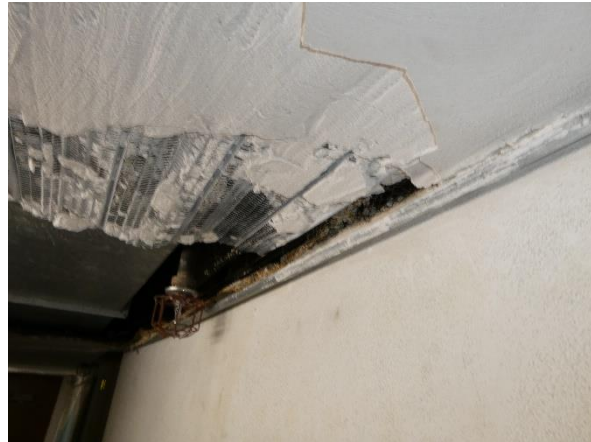
Photo 104 - Building 320: Damaged corridor plaster ceiling finishes.

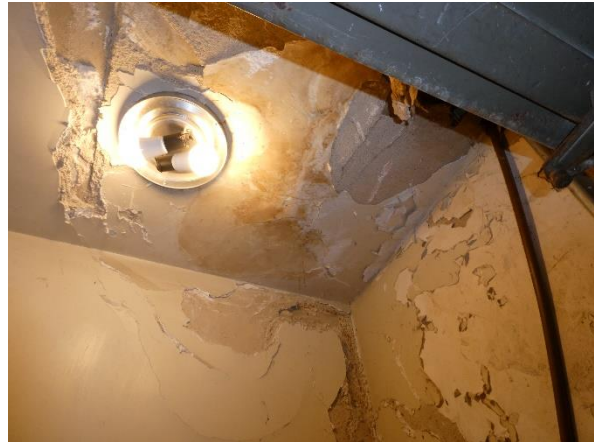
Photo 110 - Garage: Damaged ceiling and wall finishes.

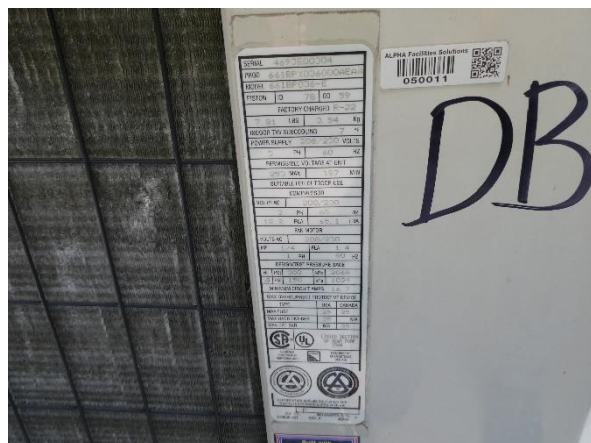
Photo 138 - Building 340: Corroded condenser unit coil fins.
