HYDROGEOLOGY EVALUATION AND RESISTIVITY SURVEY SUMMARY REPORT

Malaga Cove Plaza Area, Palos Verdes Estates

Project SC1425

July 24, 2024

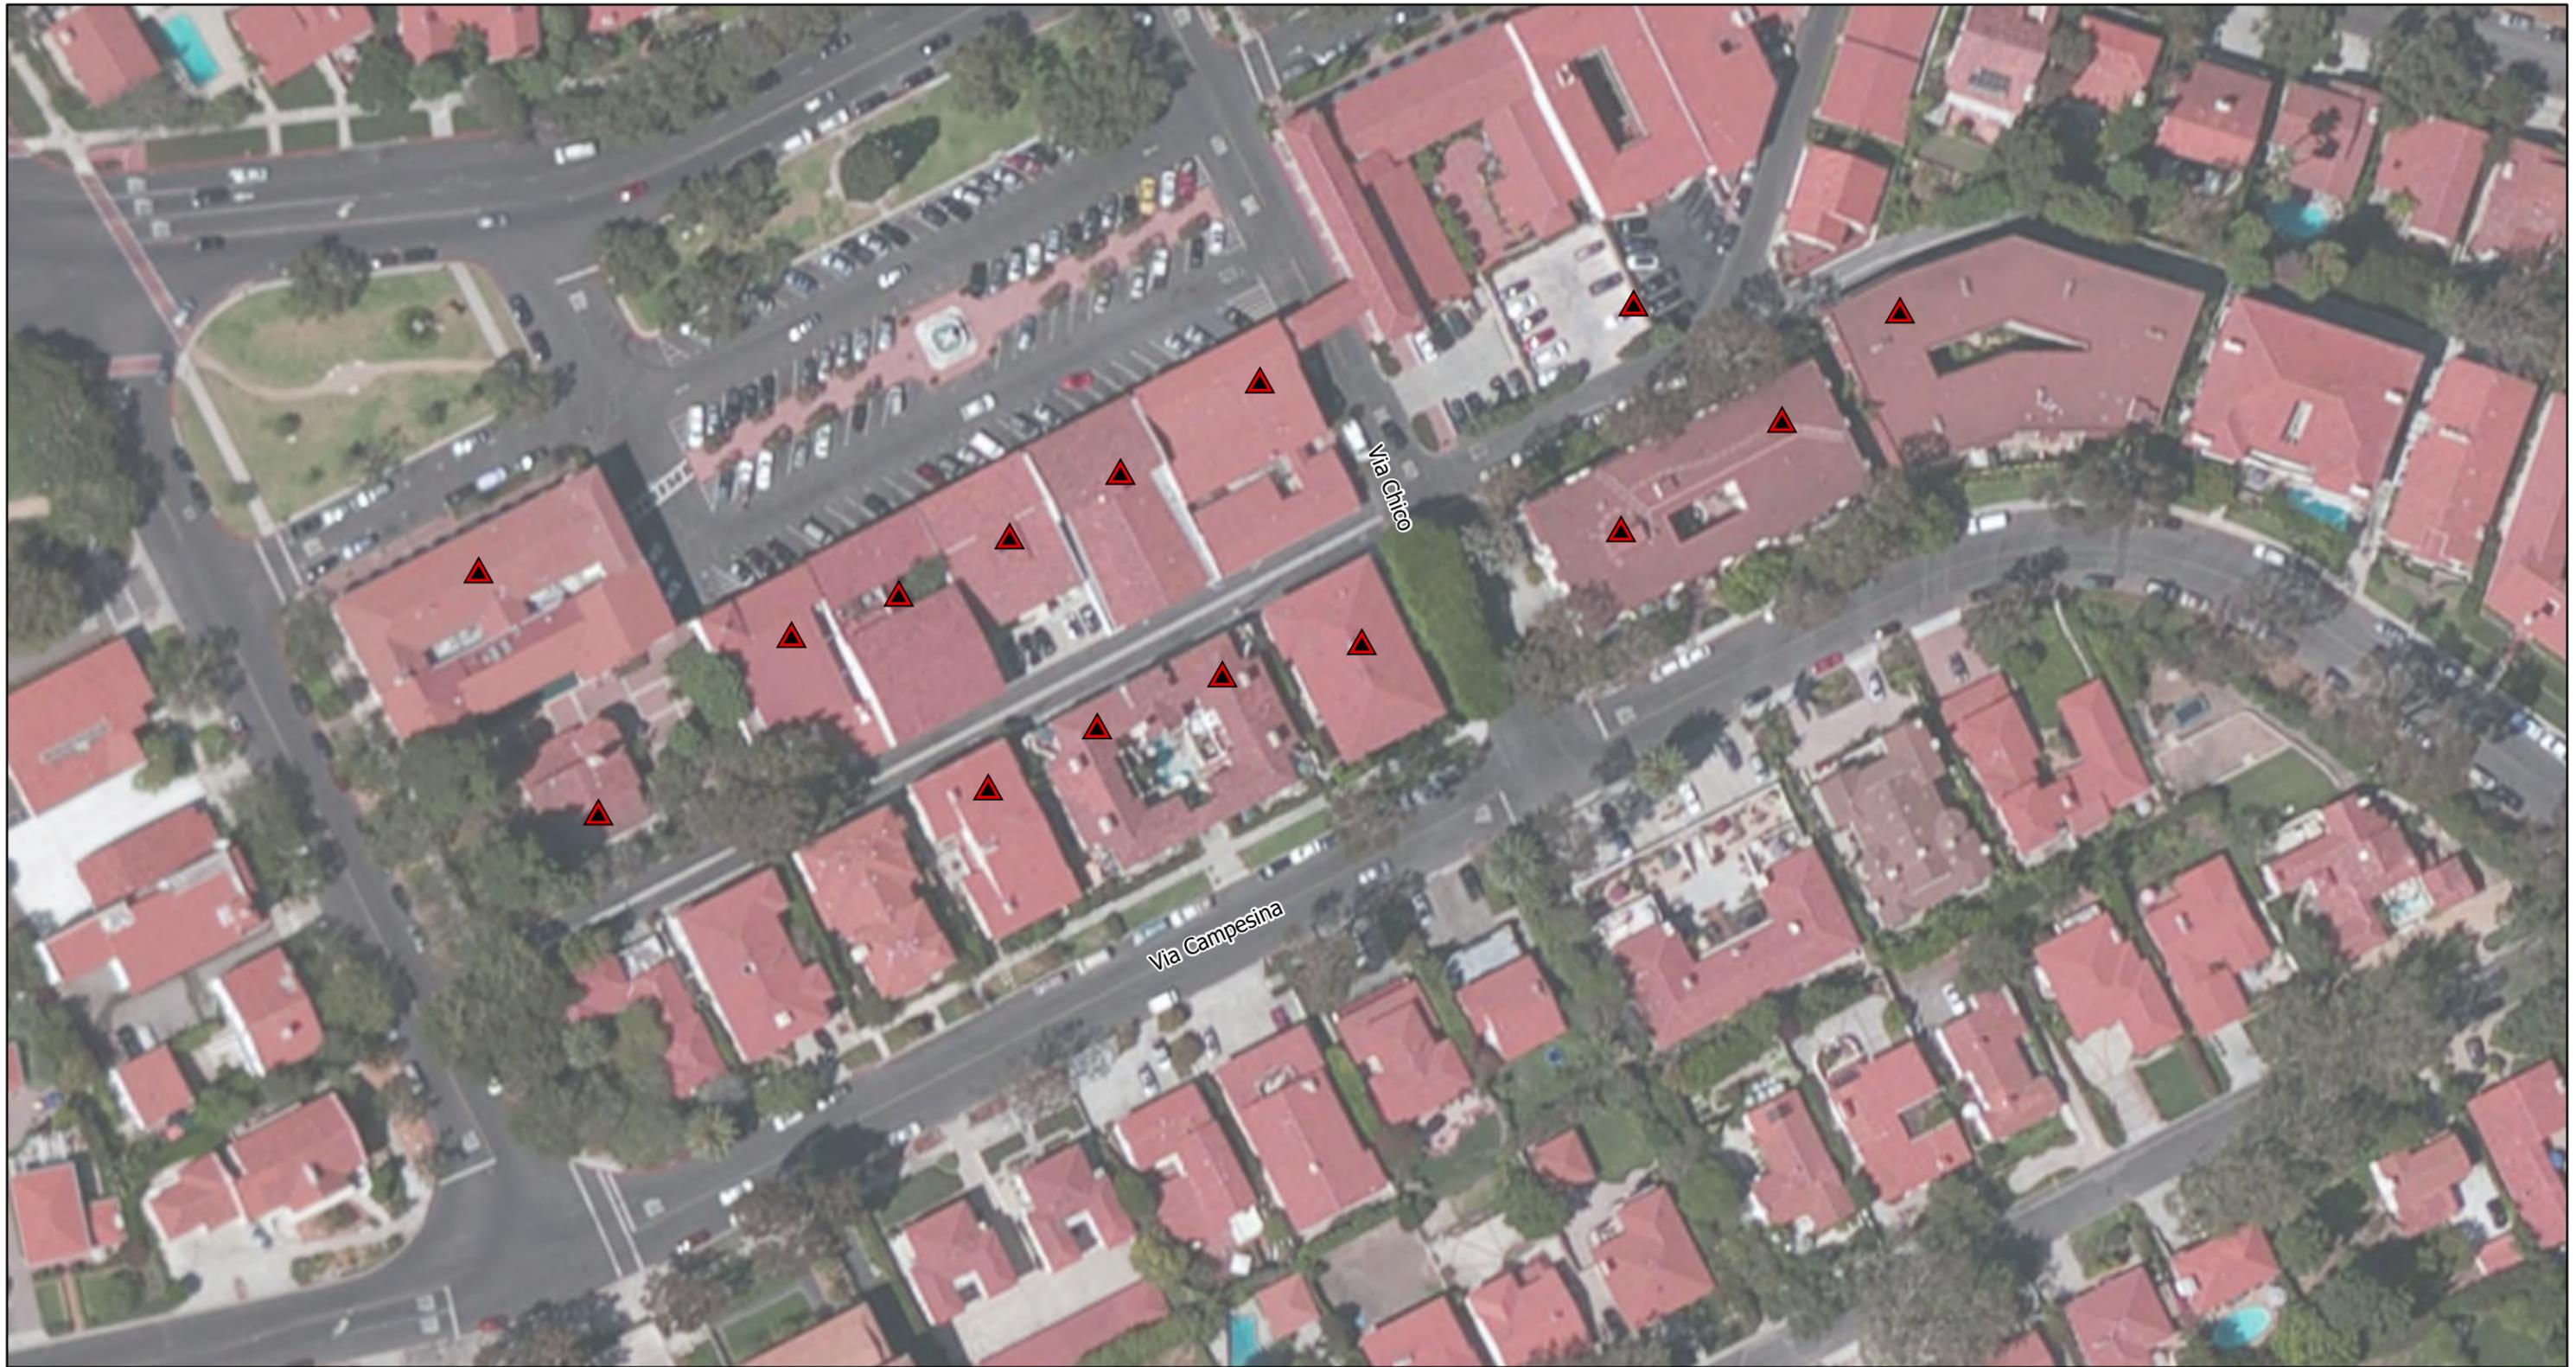
Known Groundwater Seepage Locations

Groundwater seepage locations are visually noticeable throughout the Malaga Cove Plaza area, with flowing water observed during site walks. However, some seepage points are not visible from street level. City of Palos Verdes Estates staff have communicated with concerned residents and property owners in the Malaga Cove Plaza area to document the known groundwater seepage locations, as shown in Figure 12.

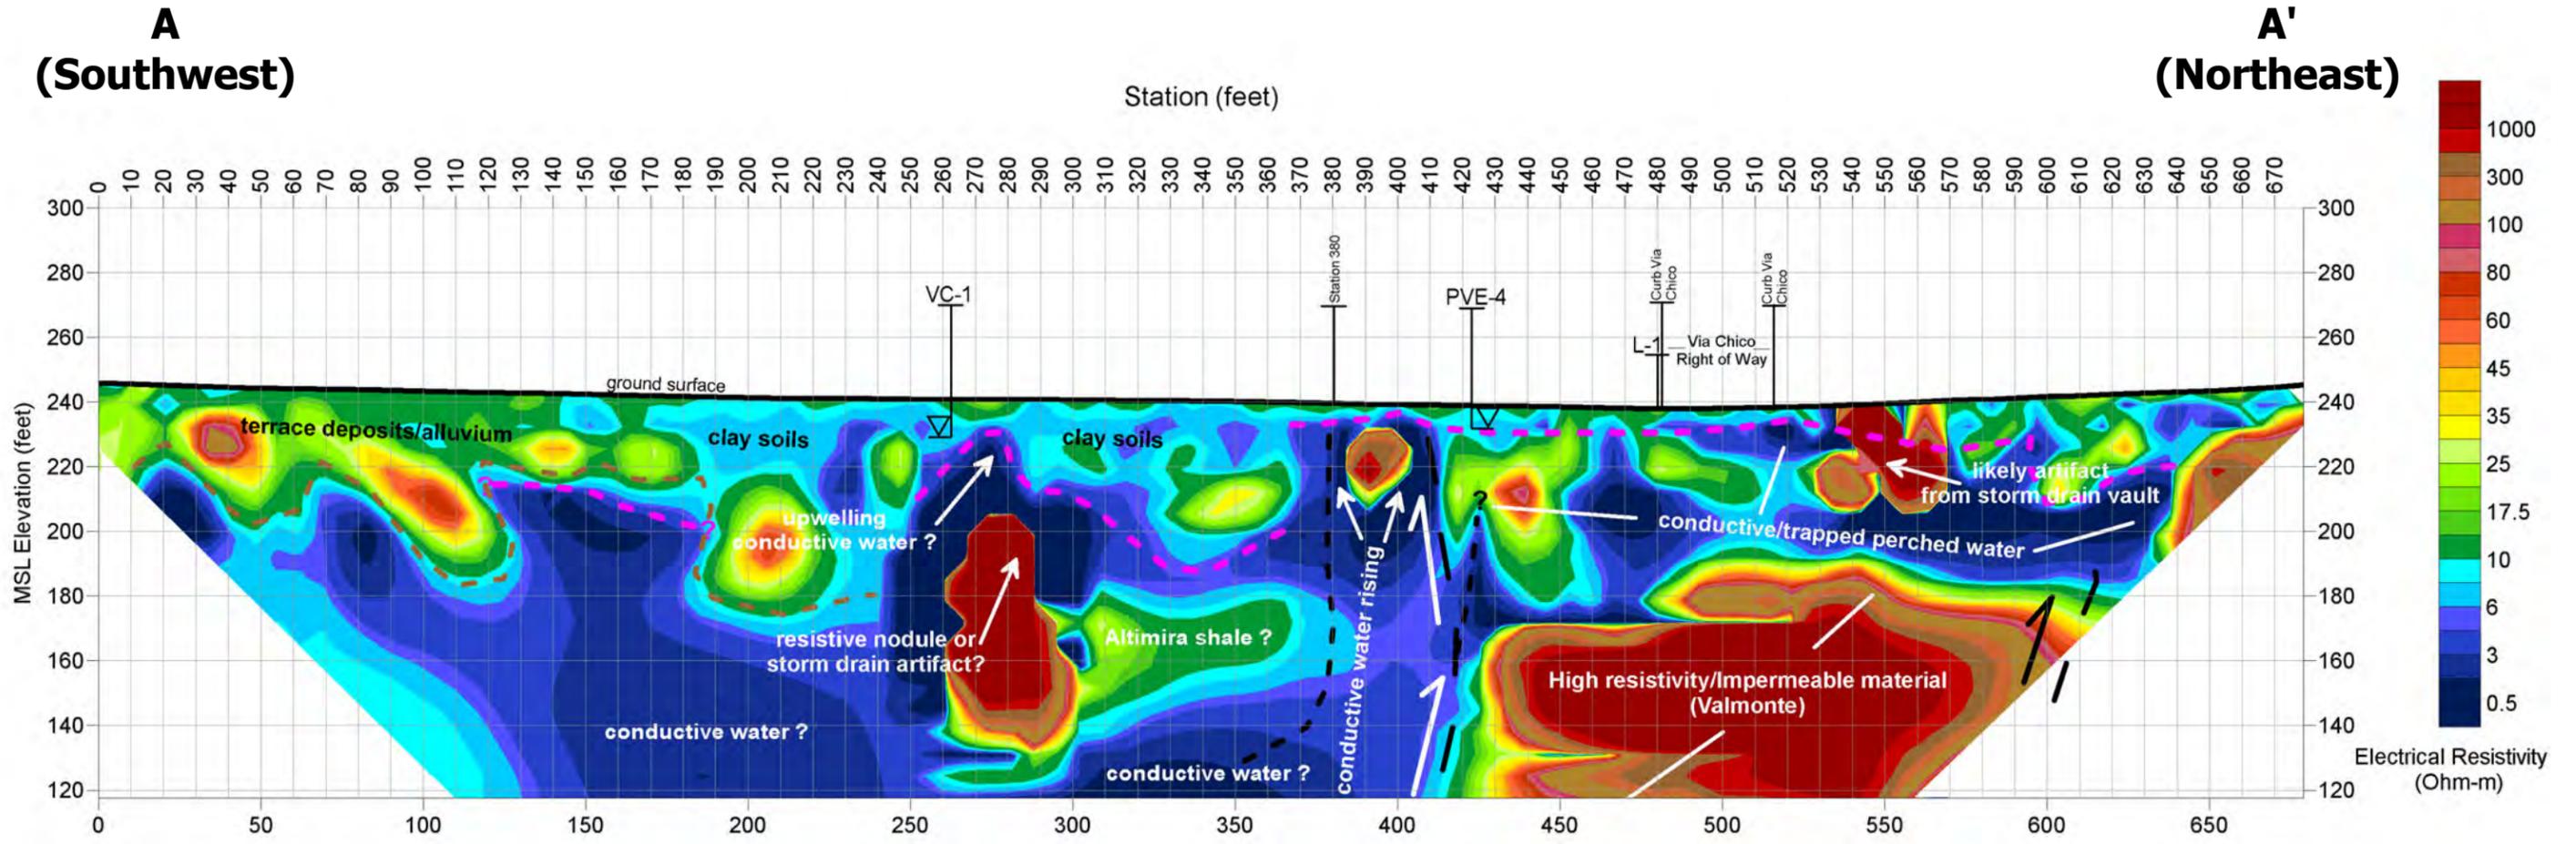
Geophysical Electrical Resistivity Cross Section A-A' along Via Campesina Malaga Cove Plaza Area Palos Verdes Estates, CA	
SC1425	June 2024
Figure 15

The resistivity profile for A-A' is shown on Figure 15. The horizontal axis represents ground distance (Station) in feet along the line, and the vertical axis represents MSL elevations in feet. The data collected along A-A' were noisier due to the presence of numerous metallic or conductive utilities, particularly steel or steel-reinforced storm drain lines, storm drain vaults, and steel water lines. These features caused noisy and erroneous data points at depth and at the northeast end of A-A'. Surface features, tie points, and key interpreted geologic and hydrogeologic units are labeled on the profile on Figure 15.

South of Station 420, a 40-foot wide vertical to subvertical zone of fractured, saturated rock is evident between Stations 380 and 420, characterized by very low resistivity values (0.1 to 3 Ohm-meters, darkest blue to deep blue). This zone, interpreted as bordering the main fault, suggests vertically rising conductive water through fractured rock. Southwest of this zone, a

The northeastern boundary of the fault block appears around Station 620 at a depth of about 65 feet bgs (178 feet MSL), where there is a drop in resistivity, suggesting another zone of water-saturated fractured rock. However, this feature is less well resolved due to data tapering off at depth.

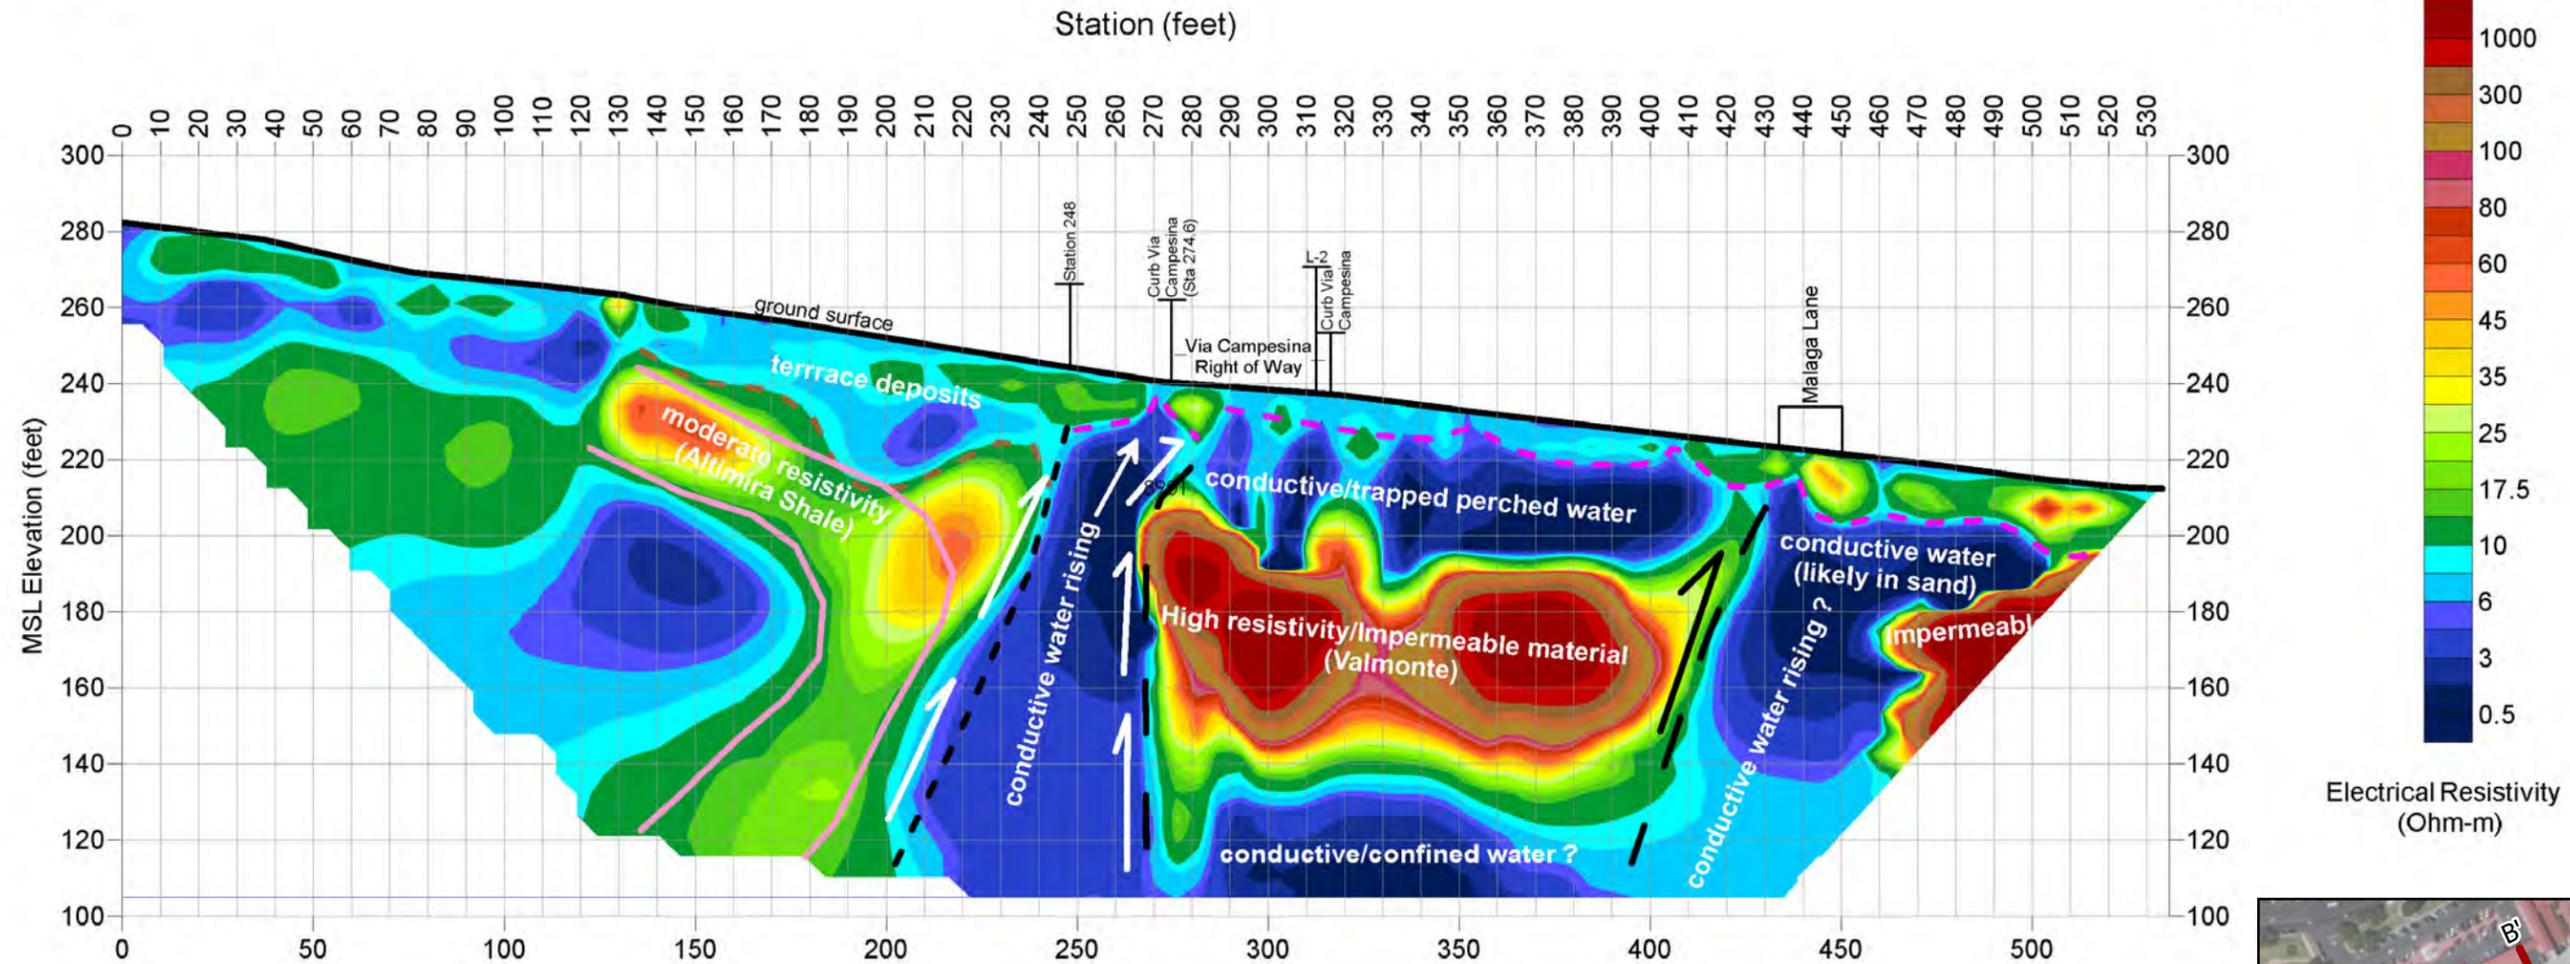
- The fault block is bordered on either side by a vertically or sub-vertically oriented fractured zone of conductive groundwater, which appears to be migrating vertically (Figures 16).

- Data collected along B-B' (Via Chico) suggest that conductive groundwater may be confined beneath the Valmonte Diatomite at depth around the fault block. This water, potentially under pressure, may be rising through the vertical or sub-vertical fractured zones (Figure 16).

The boundaries of the interpreted fault block on B-B' are shown with a heavy dashed black line in Figure 16. The resistivity data indicate that the fault block offsets the Altamira Shale unit of the Monterey Formation (to the south at about 22 feet bgs) with the Valmonte Diatomite unit (to the north at about 32 feet bgs). Between these two units is a near-vertical, steeply south-dipping zone of fractured, saturated rock.

The south end of the fault block projects to Station 270 on B-B', with the vertical/subvertical zone of fractured saturated rock evident between Stations 250 and 270, indicated by very low to low resistivity values (0.1 to 3 Ohm-meters, darkest blue to deep blue) extending from depth. This suggests the presence of conductive, high TDS water rising vertically through the fractured rock. South of this zone (south of Station 248), the Altamira Shale is interpreted based on a layer of moderate resistivity values, overlain by lower resistivity soils or alluvium, likely terrace deposits.

At Station 270, the Valmonte Diatomite unit appears at about 32 feet bgs, marked by very high resistivity values (500 to 3,000 Ohm-meters, brown to dark red) about 50 feet thick, extending to the north end of the fault block at Station 430. These high resistivity values suggest the Valmonte is impermeable, causing groundwater to perch above it. The top of the Valmonte contact varies between 26 and 48 feet bgs, generally around 35 to 37 feet deep within the fault block. The north end of the fault block projects to Station 430, bounded by another steeply south-dipping, fractured, and water-saturated zone, possibly with conductive water migrating sub-vertically (particularly between Stations 430 and 440). This zone lies beneath Malaga Lane.

The horizontal well or sub-drain system should extend across the interpreted fault block, with screened depths or open intervals below the existing drainage system along Malaga Lane. These wells or sub-drains should span the equivalent distance of A-A' Stations 200 to 700 (Via Campesina), covering approximately 350 feet across the fault block, starting from the northeast side of Via Chico, and extending west along Malaga Lane. The vertical depths of the horizontal wells or sub-drains should be 10-25 feet bgs, based on the data from B-B' Stations 430 to 450 and below basement and foundation elevations for existing buildings.

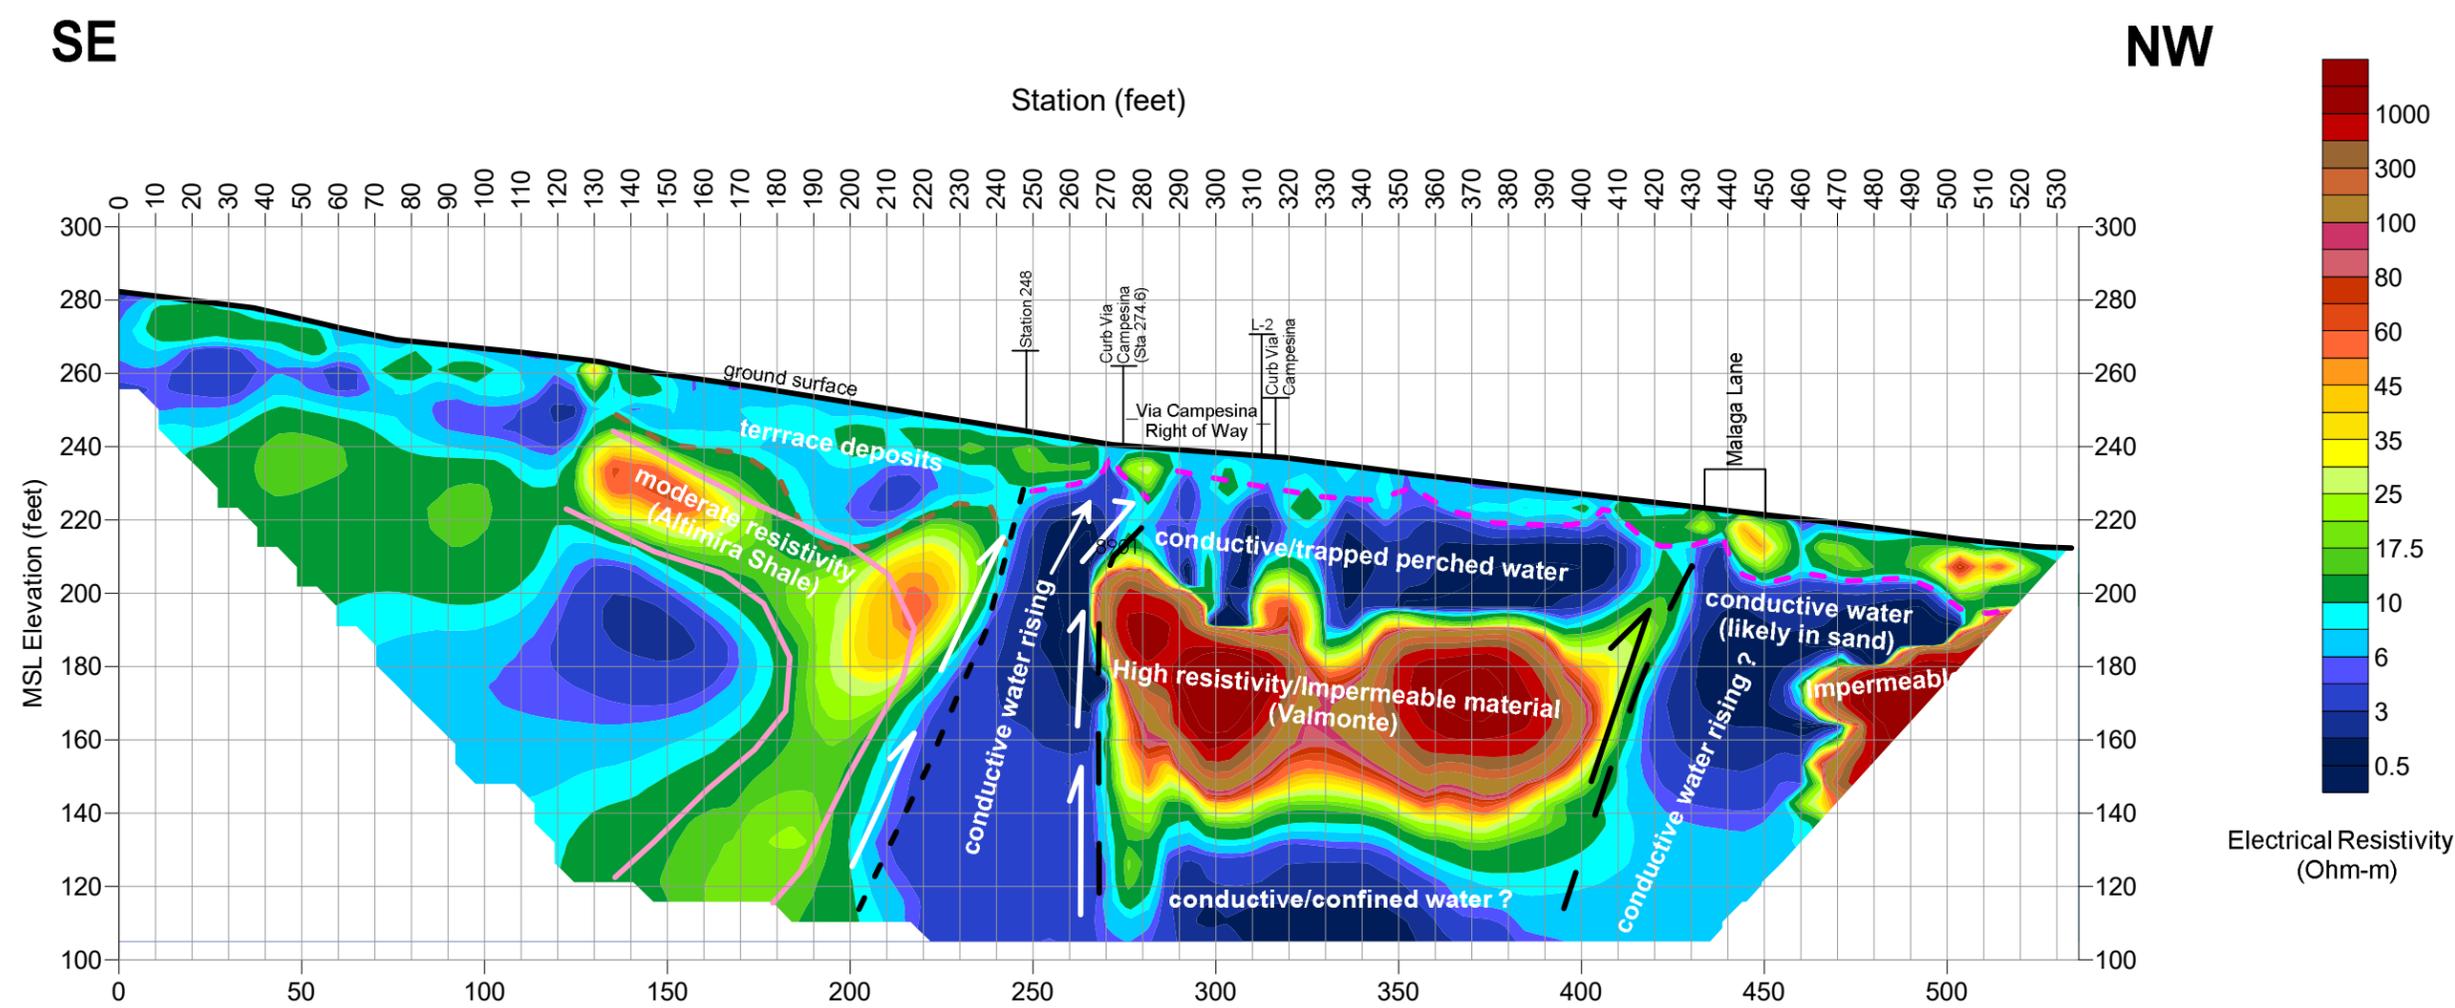
Electrical Resistivity Profile

The boundaries of the interpreted Main Fault on Line 1 are indicated with a heavy dashed black line in Figure 2. Based on the resistivity data, the feature here referred to as the “Main Fault” appears to offset the Altimira Shale unit of the Monterey Formation (to the south at a depth of about 22 feet bgs) with the Valmonte Diatomite unit (to the north at a depth of about 32 feet bgs), where a near-vertical, steeply south dipping zone of fractured saturated rock appears to be sandwiched in between these two units. The south end of the Main Fault projects to Station 274.6 on Line 1, where the vertical/subvertical zone of fractured saturated rock is evident between Stations 248 and 274.6 based on a vertical/subvertical zone of very low to low resistivity values (ranging from 0.1 to 3 Ohm-meters – darkest blue to deep blue) that appears to extend from depth. Based on these low resistivity values the water appears to be conductive and is likely high in TDS; based on the character of this low resistivity anomaly, the water appears to be rising vertically through the zone of fractured rock. South of this fractured zone (south of Station 248) the Altimira shale is interpreted based on a layer of laterally continuous moderate resistivity values, and appears to be overlain by lower resistivity soils or alluvium (likely terrace deposits).

Beginning at Station 270 the Valmonte Diatomite unit appears at a depth of about 32 feet bgs, based on the very high resistivity (500 to 3,000 Ohm-meters – brown to dark red) anomaly that is roughly 50 feet thick and extends to the north end of the fault block, which is marked by another reverse fault (at about Station 430). These high resistivity values indicate the Valmonte is impermeable, which creates a condition that appears to be causing groundwater to be perched above it. Based on the resistivity data, the top of the Valmonte contact is somewhat variable, but ranges between about 26 and 48 feet bgs, where it appears to be about 35 to 37 feet deep (in general) in the area of the fault block. As previously stated, the north end of the fault block projects to about Station 430 on Line 1, which is bounded by another steeply south dipping, apparently fractured and water-saturated zone. Based on the character of the resistivity data this zone may have conductive water migrating vertically/sub-vertically through it (particularly between Stations 430 and 440); it is interesting to note this feature lies beneath Malaga Lane, as shown in Figure 2. However, based on the resistivity values (5 to 7 Ohm-meters) below about 83 feet bgs this rising water may be either less conductive than the water on the south side of the fault block, or it does not extend to great depths. Because the data are less resolved at this depth this cannot be determined. Northwest of the fault block the Valmonte appears to be absent, where the second reverse fault (projecting to Station 430) is interpreted to offset Valmonte to the south against saturated dune sand to the north. Beginning at about Station 461 at a depth of about 40 feet, another high resistivity/likely impermeable contact is evident in the data; however, this feature is not well resolved, as the data begin to taper off at depth in this area of the profile.
