Re: Property Condition Assessment Report for *Palos Verdes Estates City Hall Buildings and Parking Structure and Seismic Evaluation Palos Verdes Estates, California 90274 Walker Consultants Project No. 37-009696.01*

## Property Condition Assessment Report

Palos Verdes Estates City Hall  
Buildings and Parking Structure and Seismic Evaluation  
Palos Verdes Estates, California  
Walker Project No. 37-009696.01  
November 30, 2023

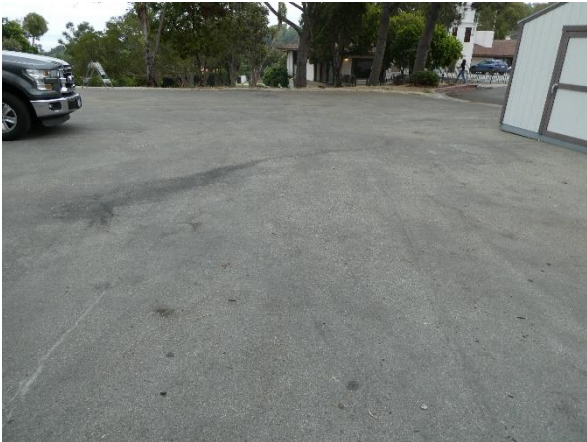
Photo 1 - Remote Lot: Condition of the asphaltic concrete pavement.

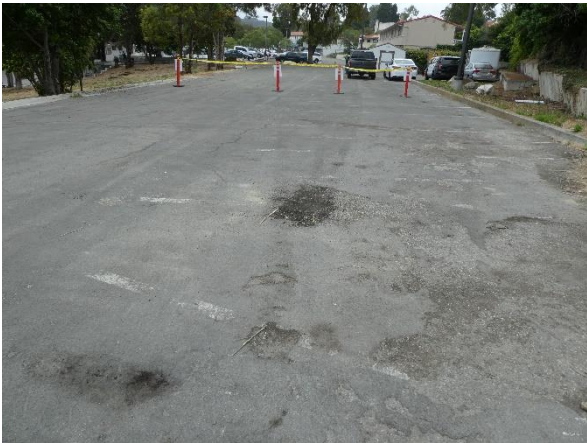
Photo 3 - Remote Lot: Overview of the condition of the pavement, looking to the east.

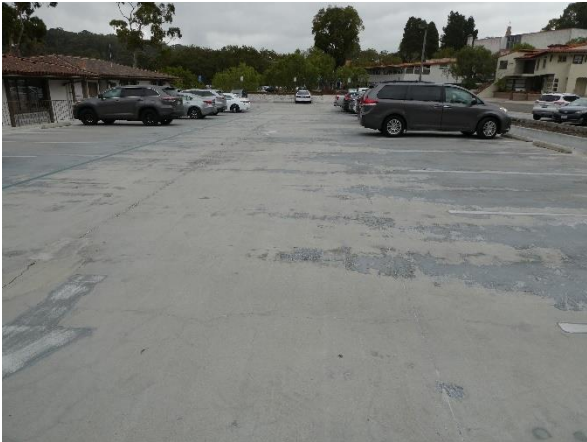
Photo 7 - Overview of the condition of the parking  
□

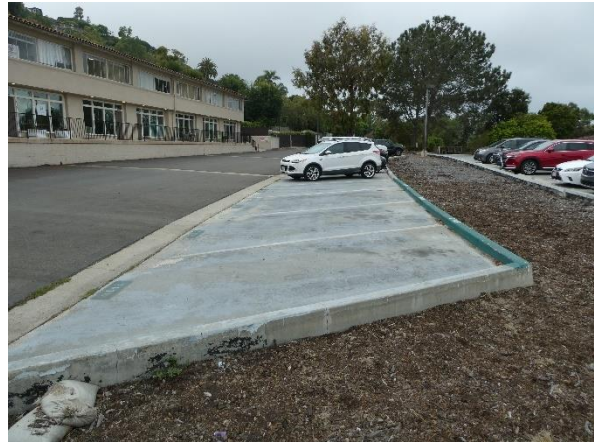
Photo 8 - Condition of the surface parking adjacent to the  
□□□

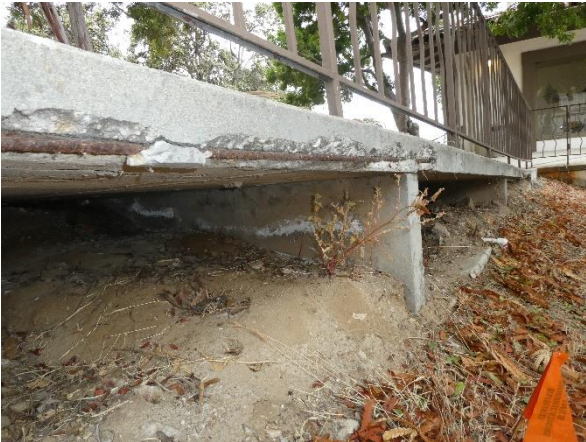
Photo 13 - Exposed rebar and spalled concrete at the site ramp.

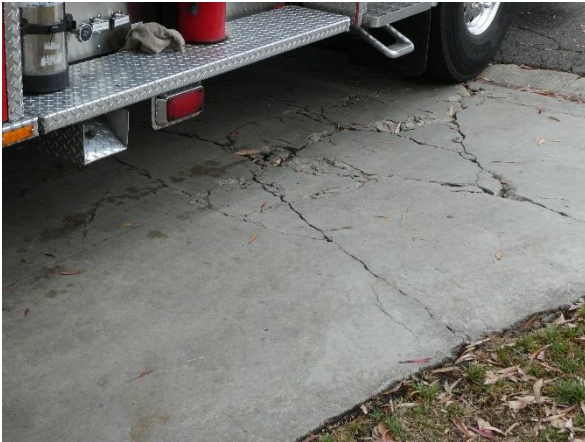
Photo 19 - Damaged concrete apron.

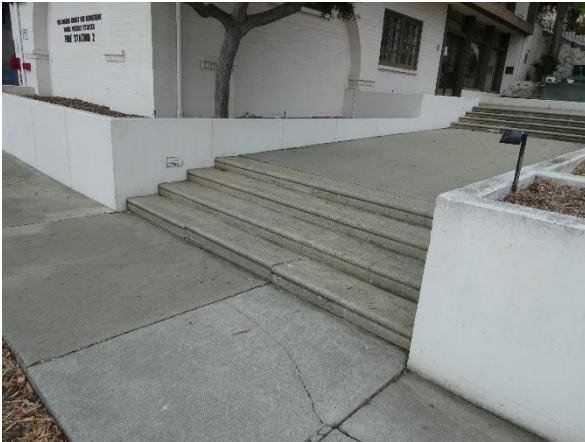
Photo 25 - End and intermediate handrails not provided at site stairs.

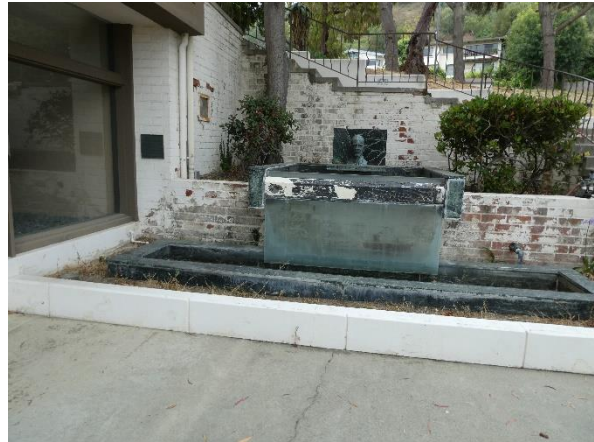
Photo 26 - Non-functioning water feature.

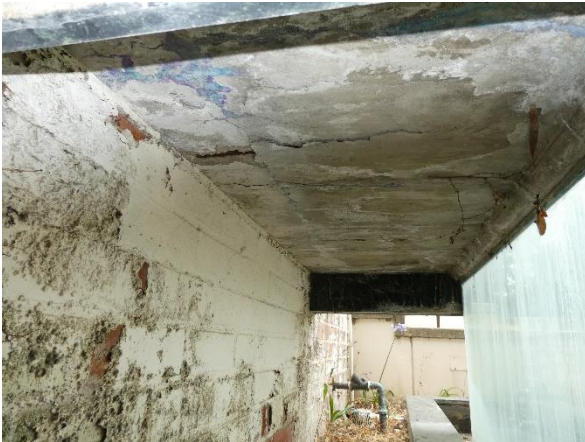
Photo 27 - Condition of cast-in-place concrete at the water feature.

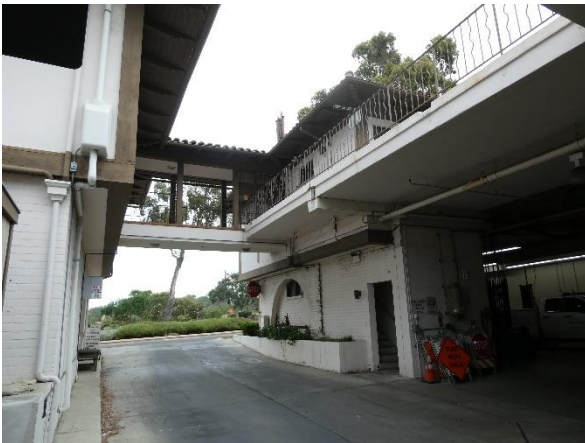
Photo 29 - Building 320: West elevation.

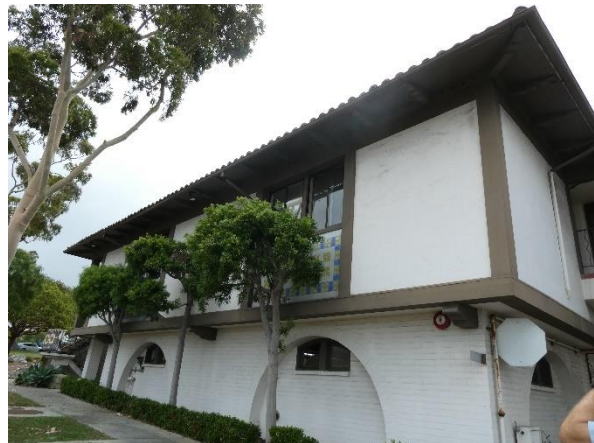
Photo 30 - Building 320: North elevation.

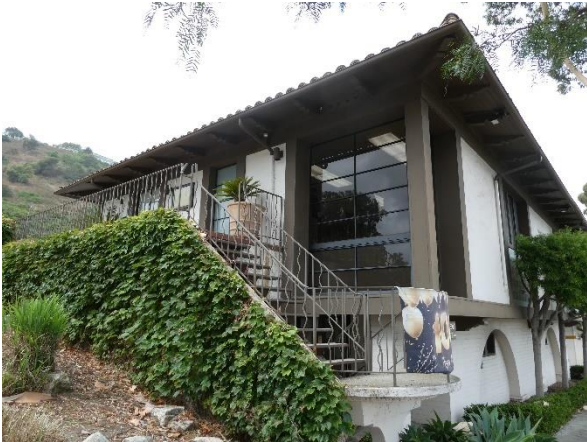
Photo 31 - Building 320: East elevation. Note: Guardrail not provided.

BES.2	Allowance to replace damaged wood trim.	NA	AL	\$ 3,500	1	\$ 3,500		\$3,500								
BES.3	Building 320: Provide guardrail, handrails and extensions, and closed risers at the east building elevation.	NA	AL	\$ 25,000	1	\$ 25,000		\$25,000								
BES.4	Building 340: Allowance to repair the tile at the tower.	NA	AL	\$ 5,000	1	\$ 5,000		\$5,000								
BES.5	Allowance to refinish the metal access door at the elevated walkway.	NA	AL	\$ 10,000	1	\$ 10,000		\$10,000								
BES.6	Provide handrails and handrail extensions where missing.	NA	AL	\$ 7,500	1	\$ 7,500		\$7,500								
<b>ROOFING</b>																
R.1	Replace damaged and missing terra-cotta tiles.	NA	SF	\$ 25	1,900	\$ 47,500	\$47,500									
R.2	Remove terra-cotta tiles, replace the roof underlayment, and reinstall the terra-cotta roof tiles.	20	SF	\$ 30	19,300	\$ 579,000	\$579,000									
R.3	Repair missing ceramic tile at the tower.	NA	AL	\$ 5,000	1	\$ 5,000	\$5,000

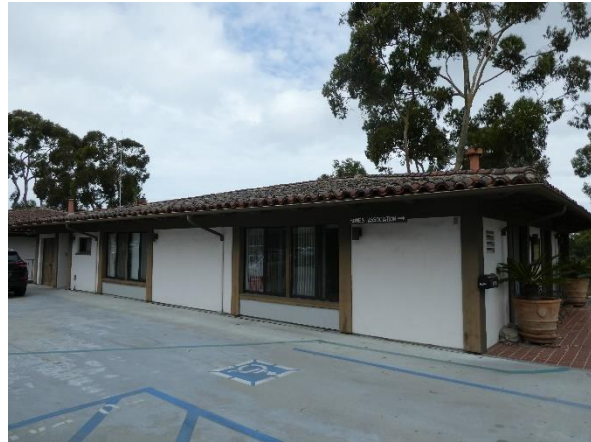
Photo 32 - Building 320: South elevation.

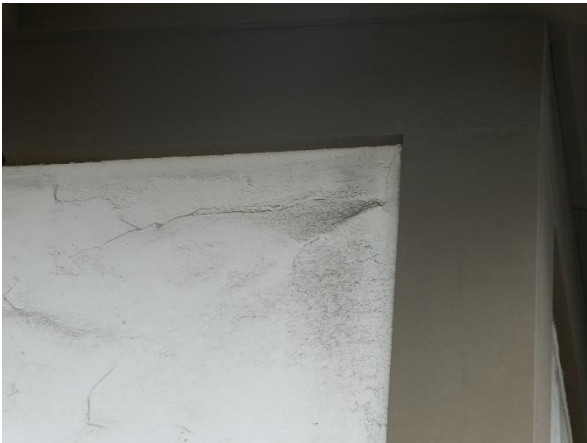
Photo 33 - Building 320: Soiled painted finishes.

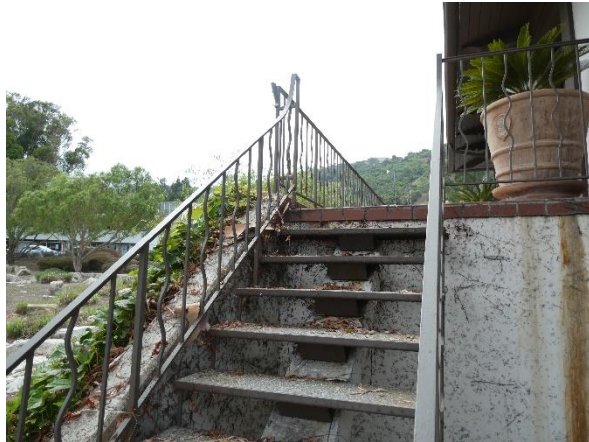
Photo 38 - Building 320: Open risers and excessive baluster spacing at the building stairs. Note: Guardrail not provided.

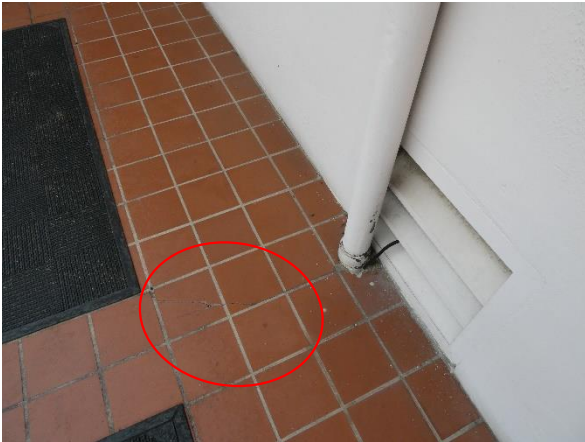
Photo 43 - Elevated walkway: Cracked flooring.

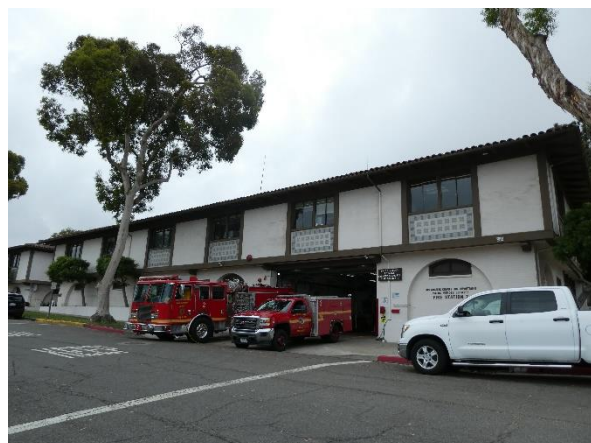
Photo 48 - Building 340: North elevation.

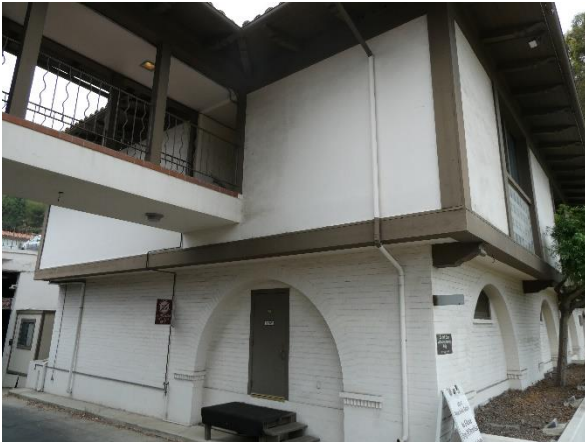
Photo 49 - Building 340: East elevation.

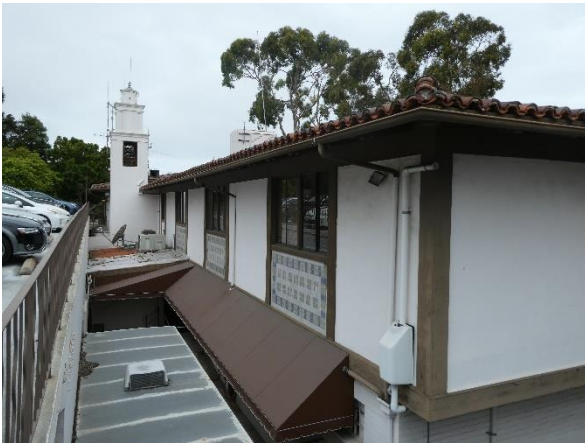
Photo 51 - Building 340: South elevation.

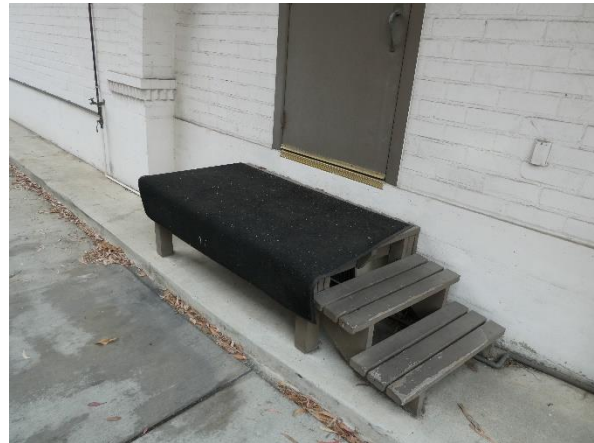
Photo 52 - Building 340: The stair assembly at the east elevation employee entrance.

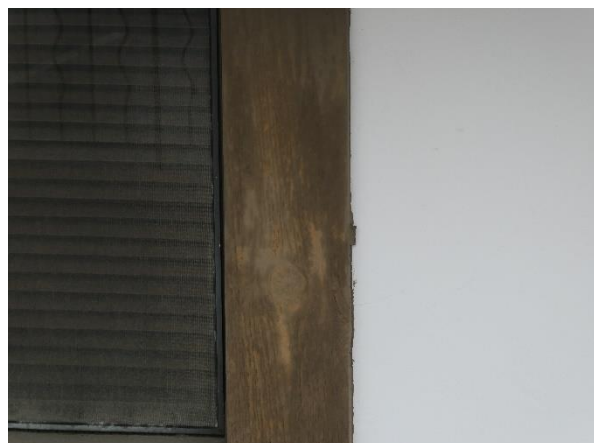
Photo 54 - Building 340: Condition of painted wood trim.

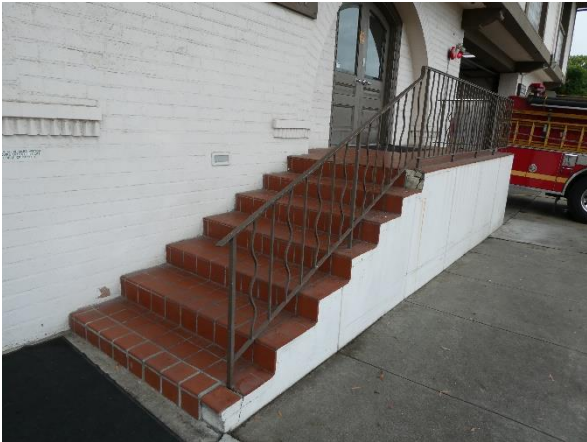
Photo 67 - Building 340 (Police Department): Handrail provided at one side, and handrail extensions not provided at the exterior stair.

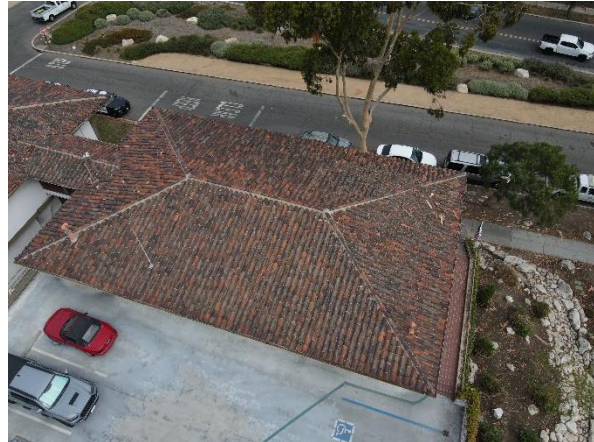
Photo 70 - Building 320: Roof overview.

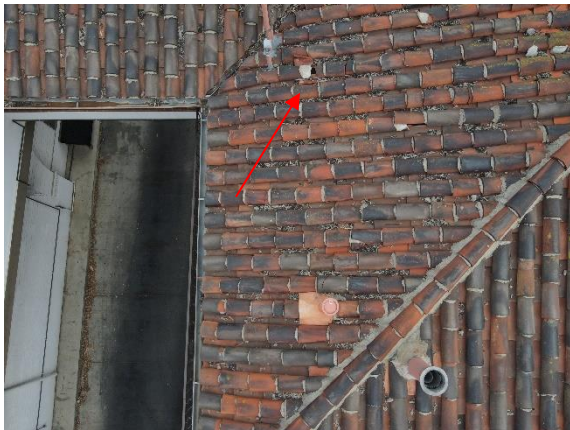
Photo 71 - Building 320: Delaminated terracotta tile throughout the field of the roof.

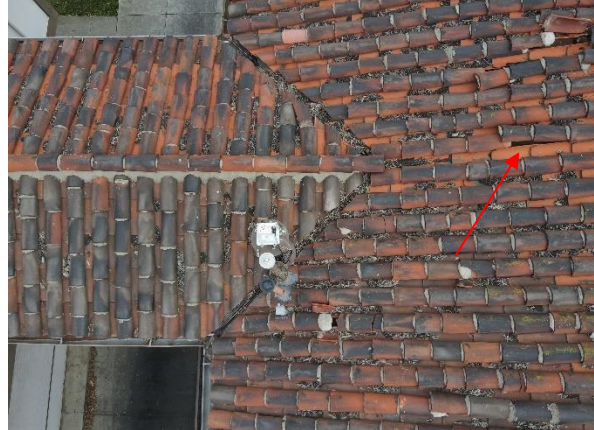
Photo 72 - Building 320: Exposed roof underlayment.

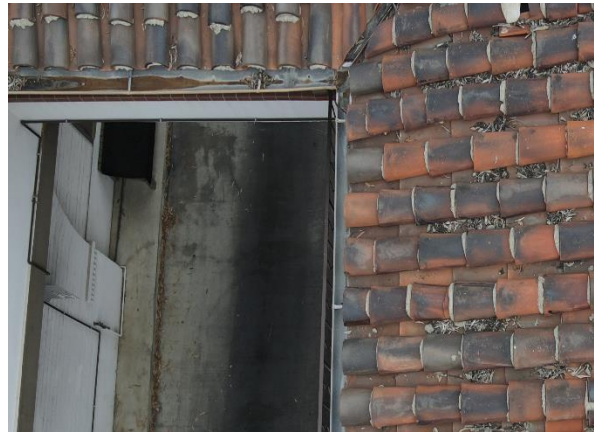
Photo 74 - Building 320: Condition of gutter system at the roof perimeter.

R.4	Replace modified bitumen roof systems.	20	AL	\$ 3,500	1	\$ 3,500	\$3,500									
R.5	Recoat/Repair metal roofs and replace fasteners.	15	SF	\$ 7.00	500	\$ 3,500	\$3,500									
R.6	Replace gutters and downspouts.	10+	LF	\$ 20	675	\$ 13,500	\$13,500									
<b>INTERIORS</b>																
IN.1	Building 340 (City Hall): Modify the guardrail baluster opening width at the monumental stair.	NA	AL	\$ 75,000	1	\$ 75,000	\$75,000									
IN.2	Building 320: Provide handrail extensions at the interior stairs from the parking garage to the Maintenance Department.	NA	AL	\$ 3,500	1	\$ 3,500	\$3,500									
<b>ELEVATORS</b>																
None																
<b>MECHANICAL/ELECTRICAL/PLUMBING</b>																
MEP.1	Repair Police Station women's locker room sink drainpipe.	NA	ALLOW	\$ 10,000	1	\$ 10,000	\$10,000									
MEP.2	Replace 400A, 240V switchboard	50+	EA	\$ 75,000	2	\$ 150,000		\$75,000				\$75,000

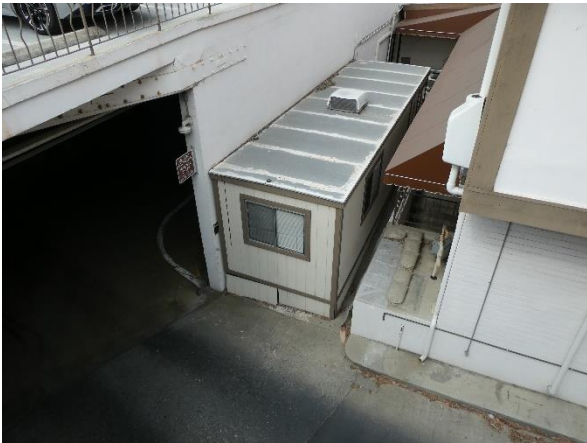
Photo 75 - Freestanding building adjacent to Building 340

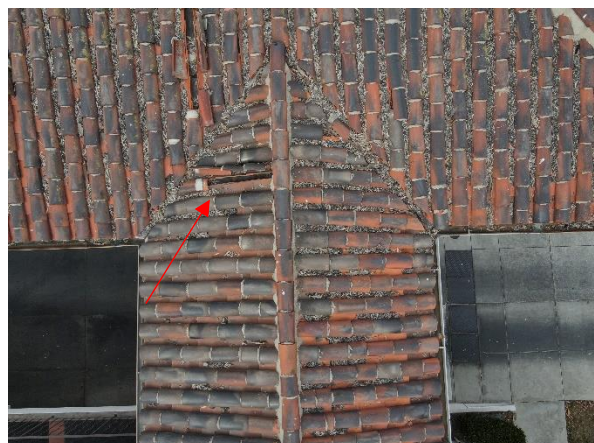
Photo 77 - Overview of walkway roof.

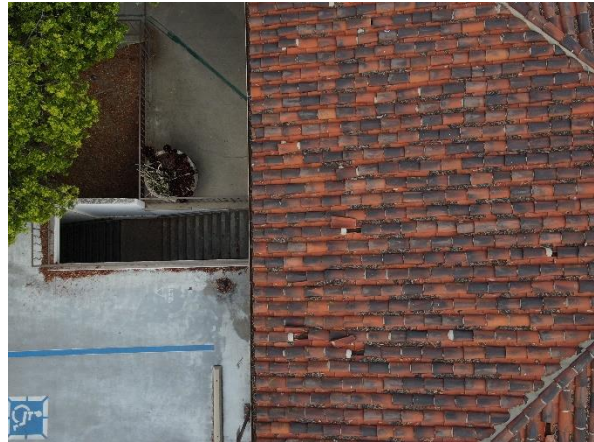
Photo 79 - Building 340: Roof overview.

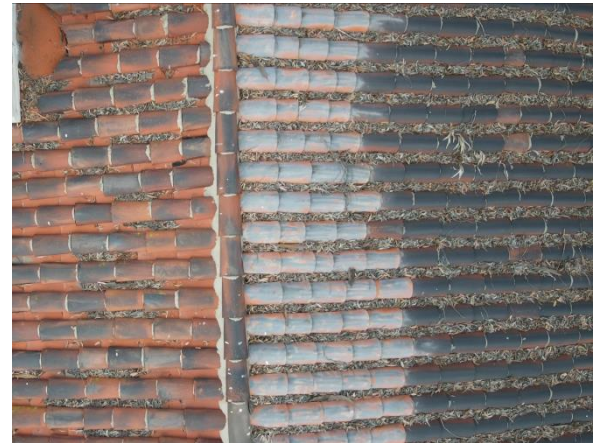
Photo 81 - Building 340: Exposed roof membrane under roof tiles.

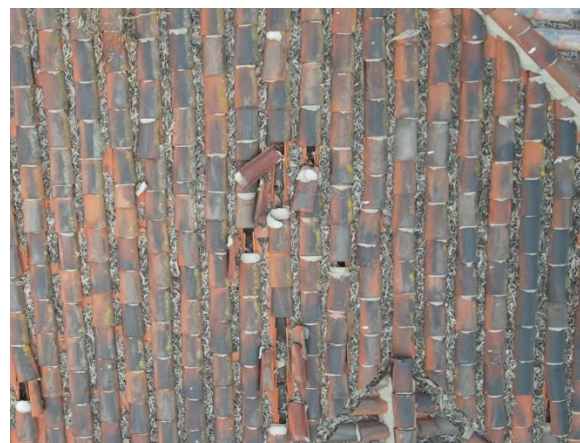
Photo 82 - Building 340: Discolored terracotta tiles at the field of the roof.

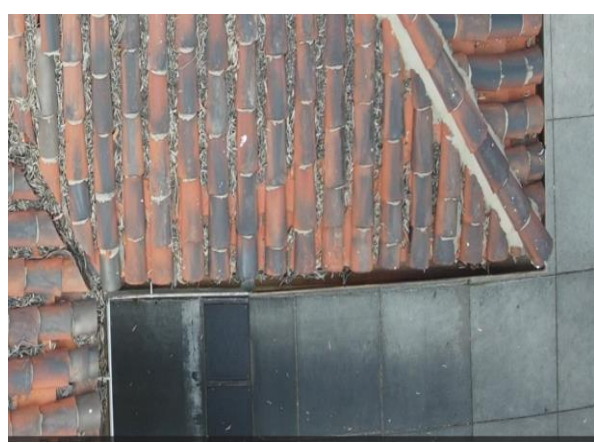
Photo 83 - Building 340: Missing fasteners at select steel components.

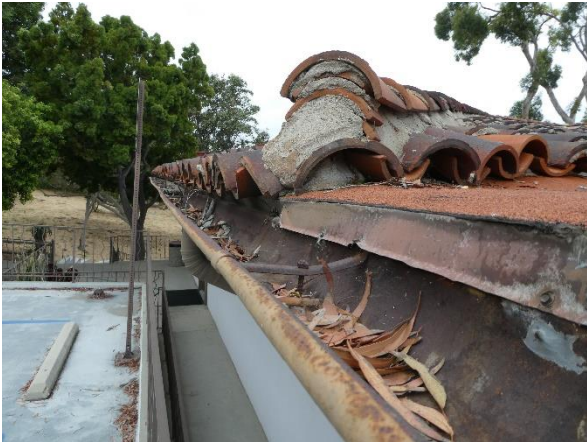
Photo 84 - Building 340: Condition of the gutter system at the roof perimeter.

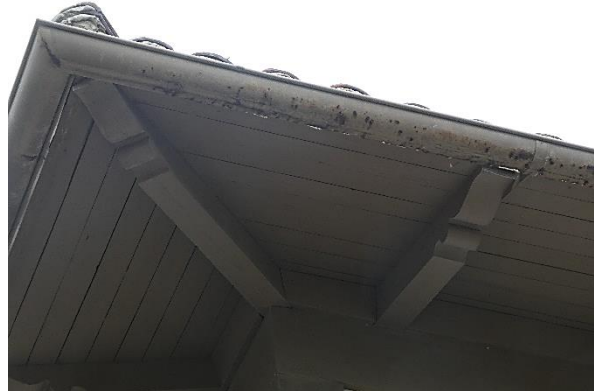
Photo 85 - Building 340: Condition of metal gutters.

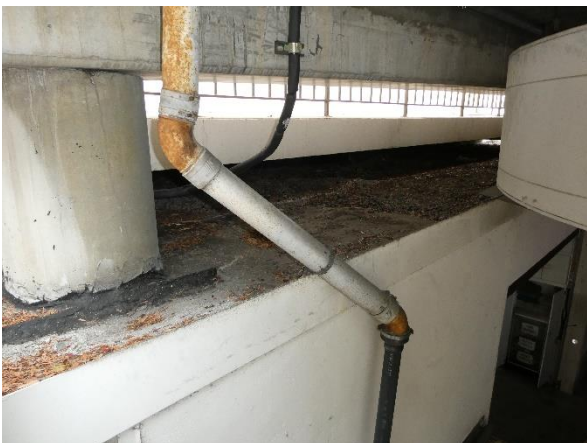
Photo 88 - Building 340: Condition of the metal roof at the West building elevation.

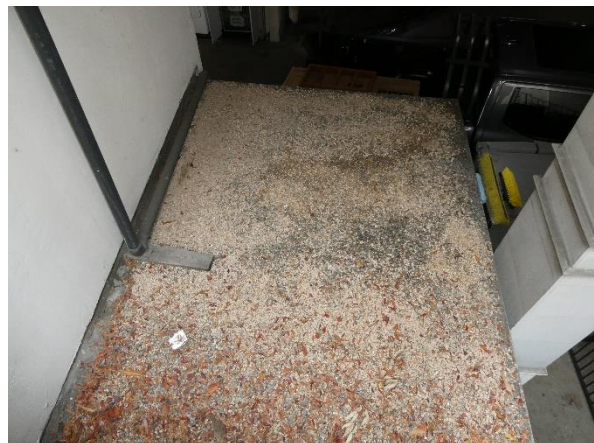
Photo 89 - Building 340: Condition of the built-up roof at the garage.

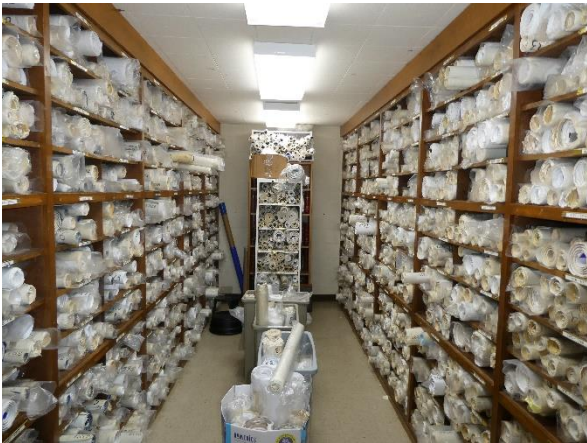
Photo 92 - storage finishes.

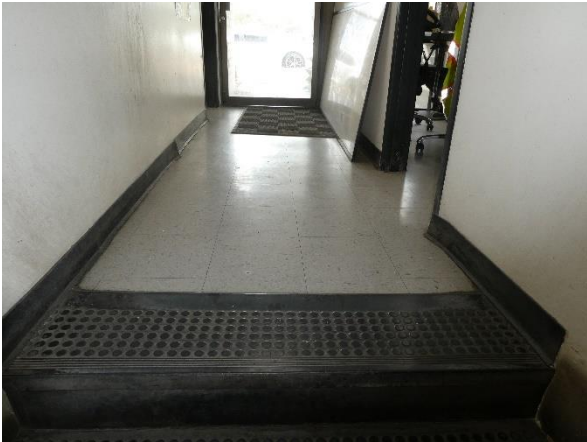
Photo 96 - Building 320: Interior stair finishes from the parking garage to the Maintenance Department.

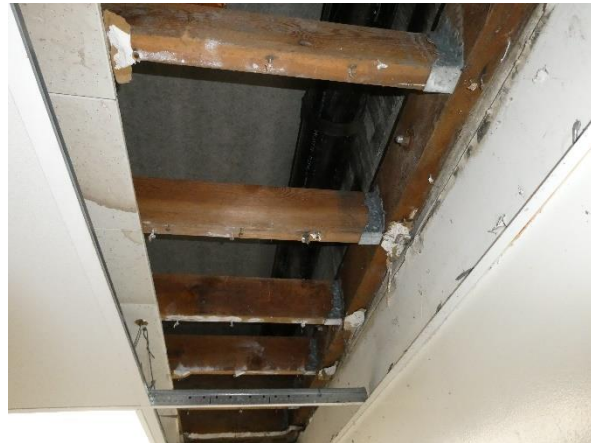
Photo 99 - Building 320 (Maintenance Department): Break  
room.

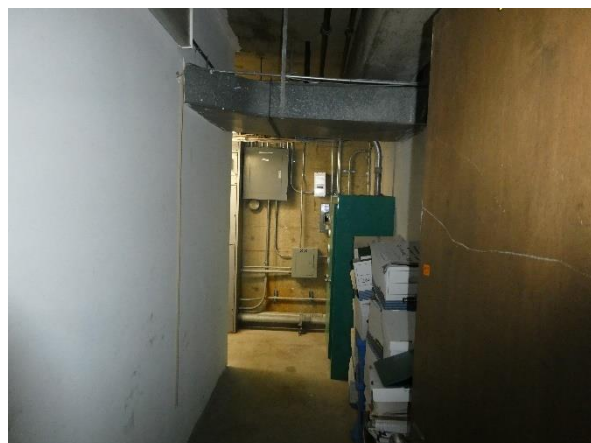
Photo 101 - Building 320: Basement corridor finishes.

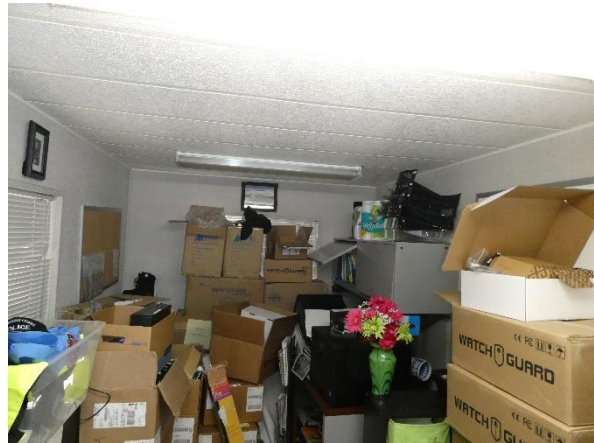
Photo 111 - Freestanding building adjacent to Building 340.

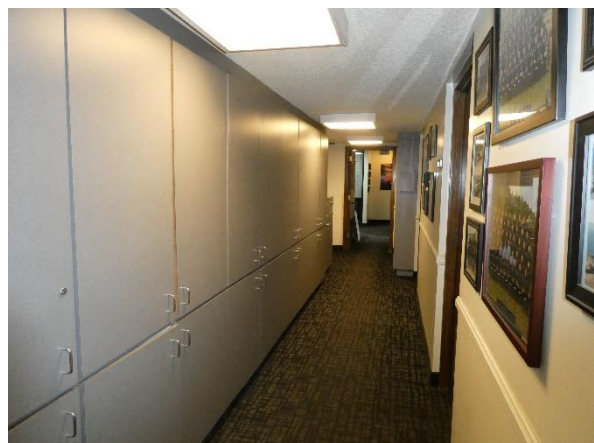
Photo 113 - Building 340 (Police Department): Reception.

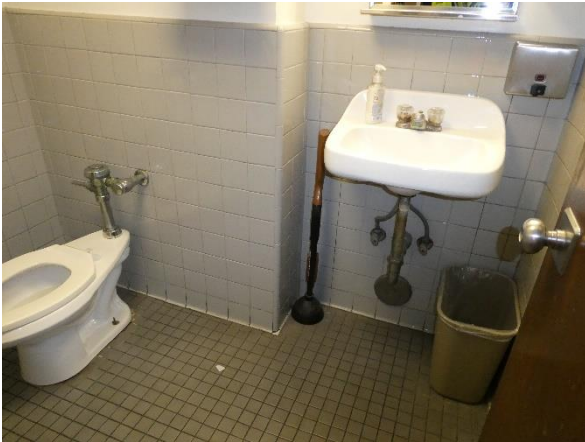
Photo 114 - Building 340 (Police Department): Interior finishes.

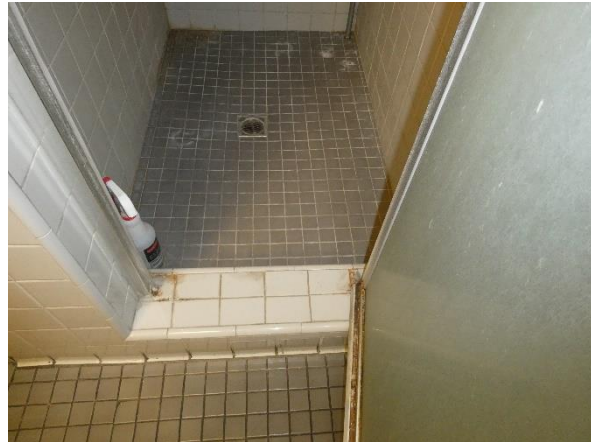
Photo 115 - Building 340 (Police Department): Bathroom.

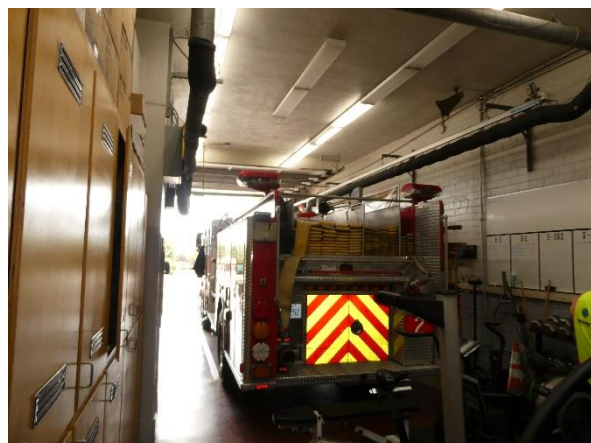
Photo 119 - Building 340 (Fire Station): Interior finishes.

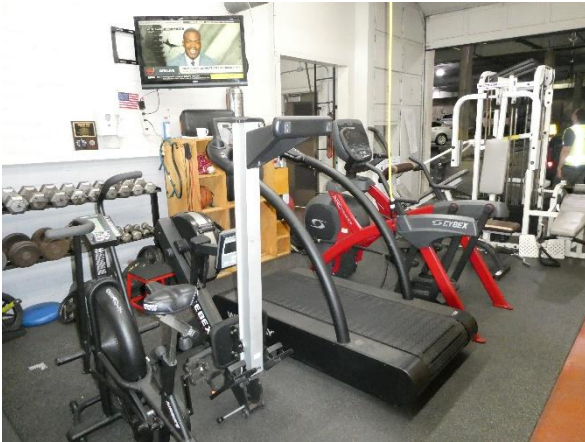
Photo 120 - Building 340 (Fire Station): Interior finishes.

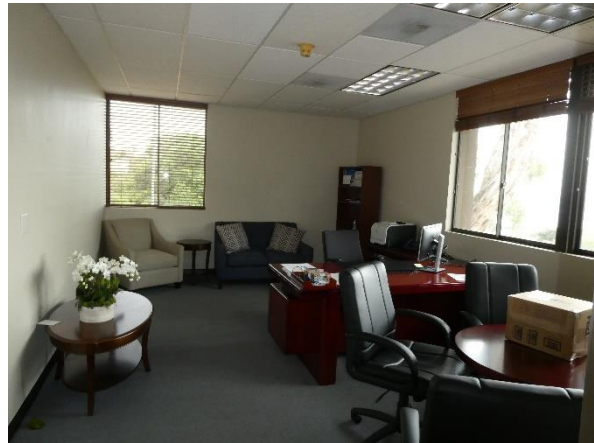
Photo 129 - Building 340 (City Hall): Office area.

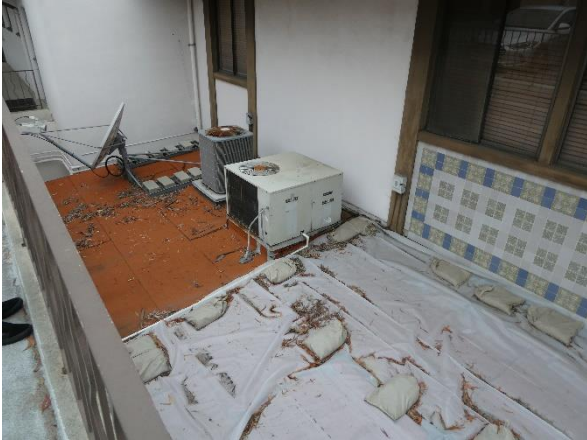
Photo 138 - Building 340: Corroded condenser unit coil fins.

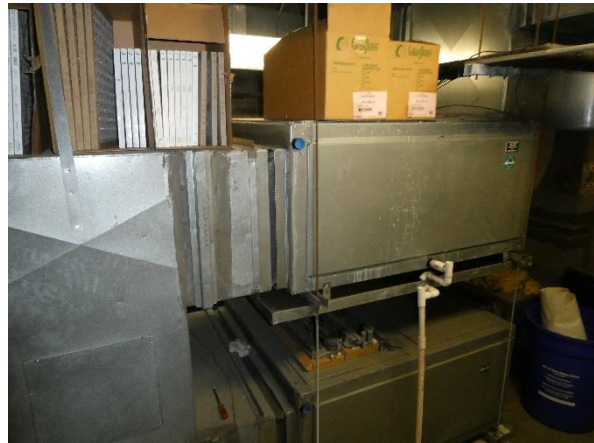
Photo 141 - Building 340: Fan/coil units mounted above suspended ceiling.

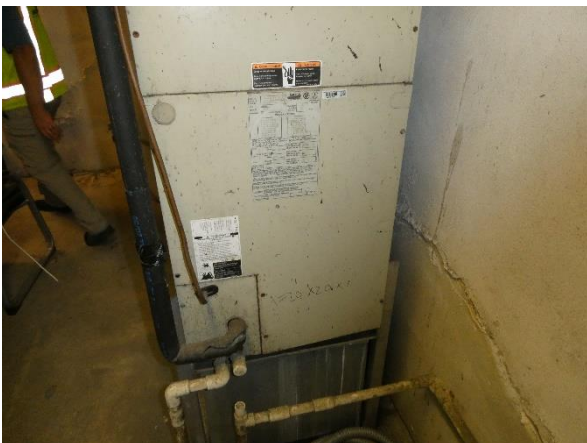
Photo 142 - Building 340: Fan/coil units located in the basement.

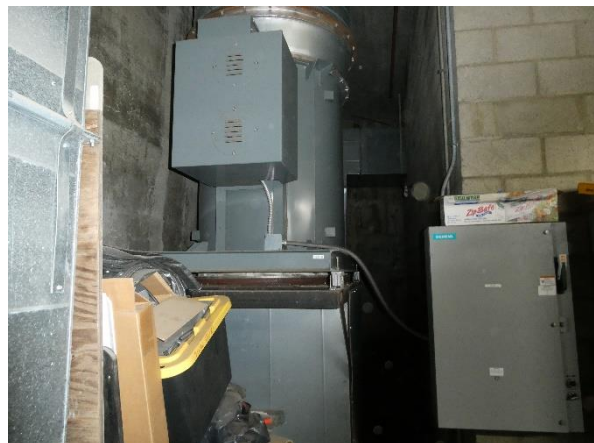
Photo 143 - Building 340: Older fan/coil units located in the basement.

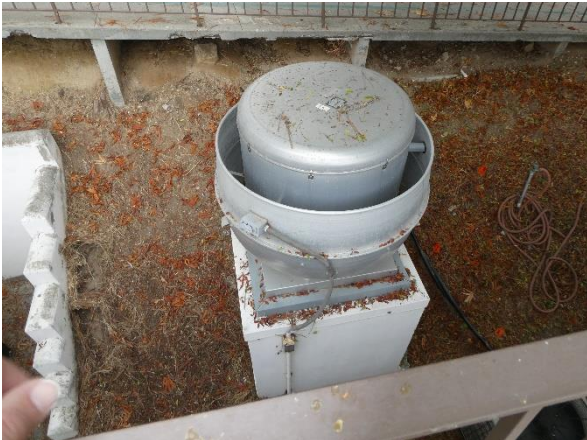
Photo 144 - Garage: East ventilation fan.

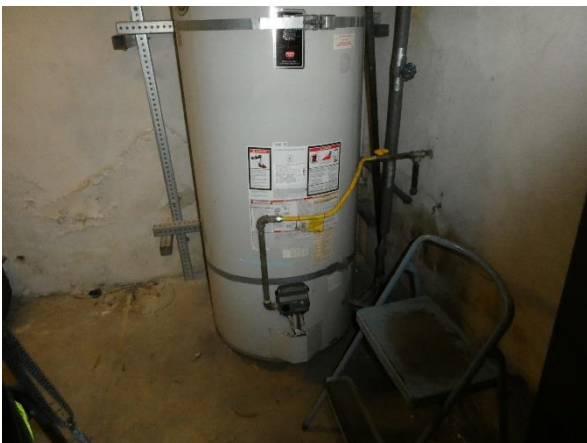
Photo 154 - Building 320: Domestic water heater.

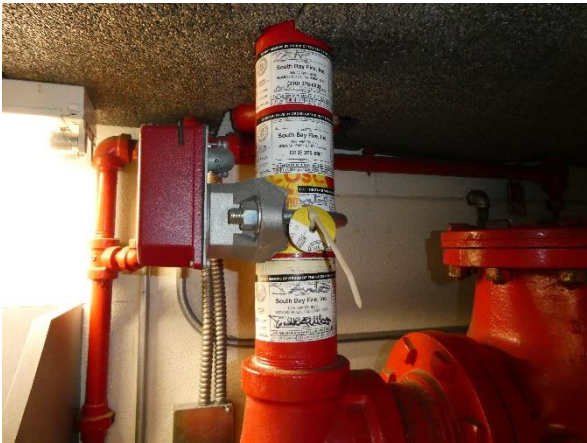
Photo 158 - Building 320: Main fire riser.

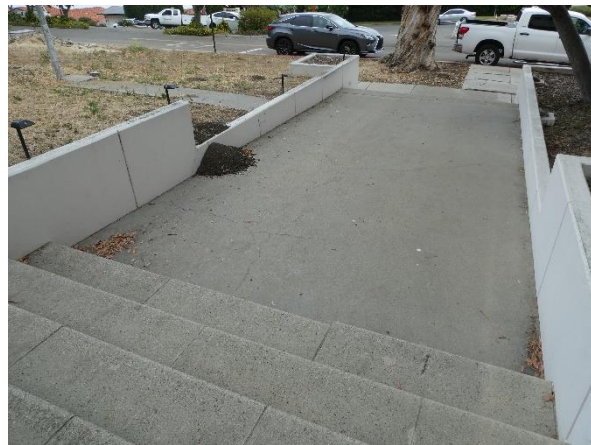
Photo 165 - Building 340 (Police Department): Main entrance is not accessible.

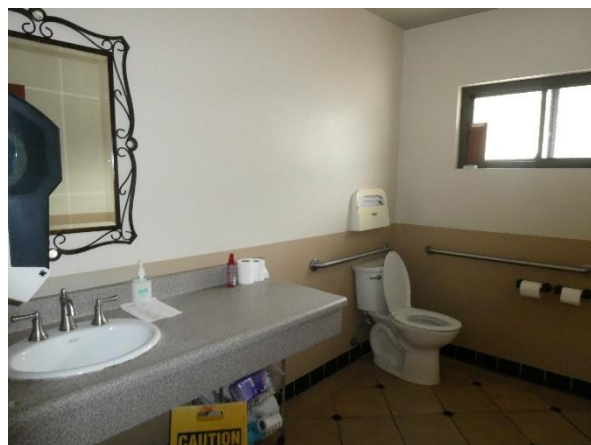
Photo 167 - Building 340 (City Hall): Accessible restroom stall.
