HYDROGEOLOGY EVALUATION AND RESISTIVITY SURVEY SUMMARY REPORT

Malaga Cove Plaza Area, Palos Verdes Estates

Project SC1425

July 24, 2024

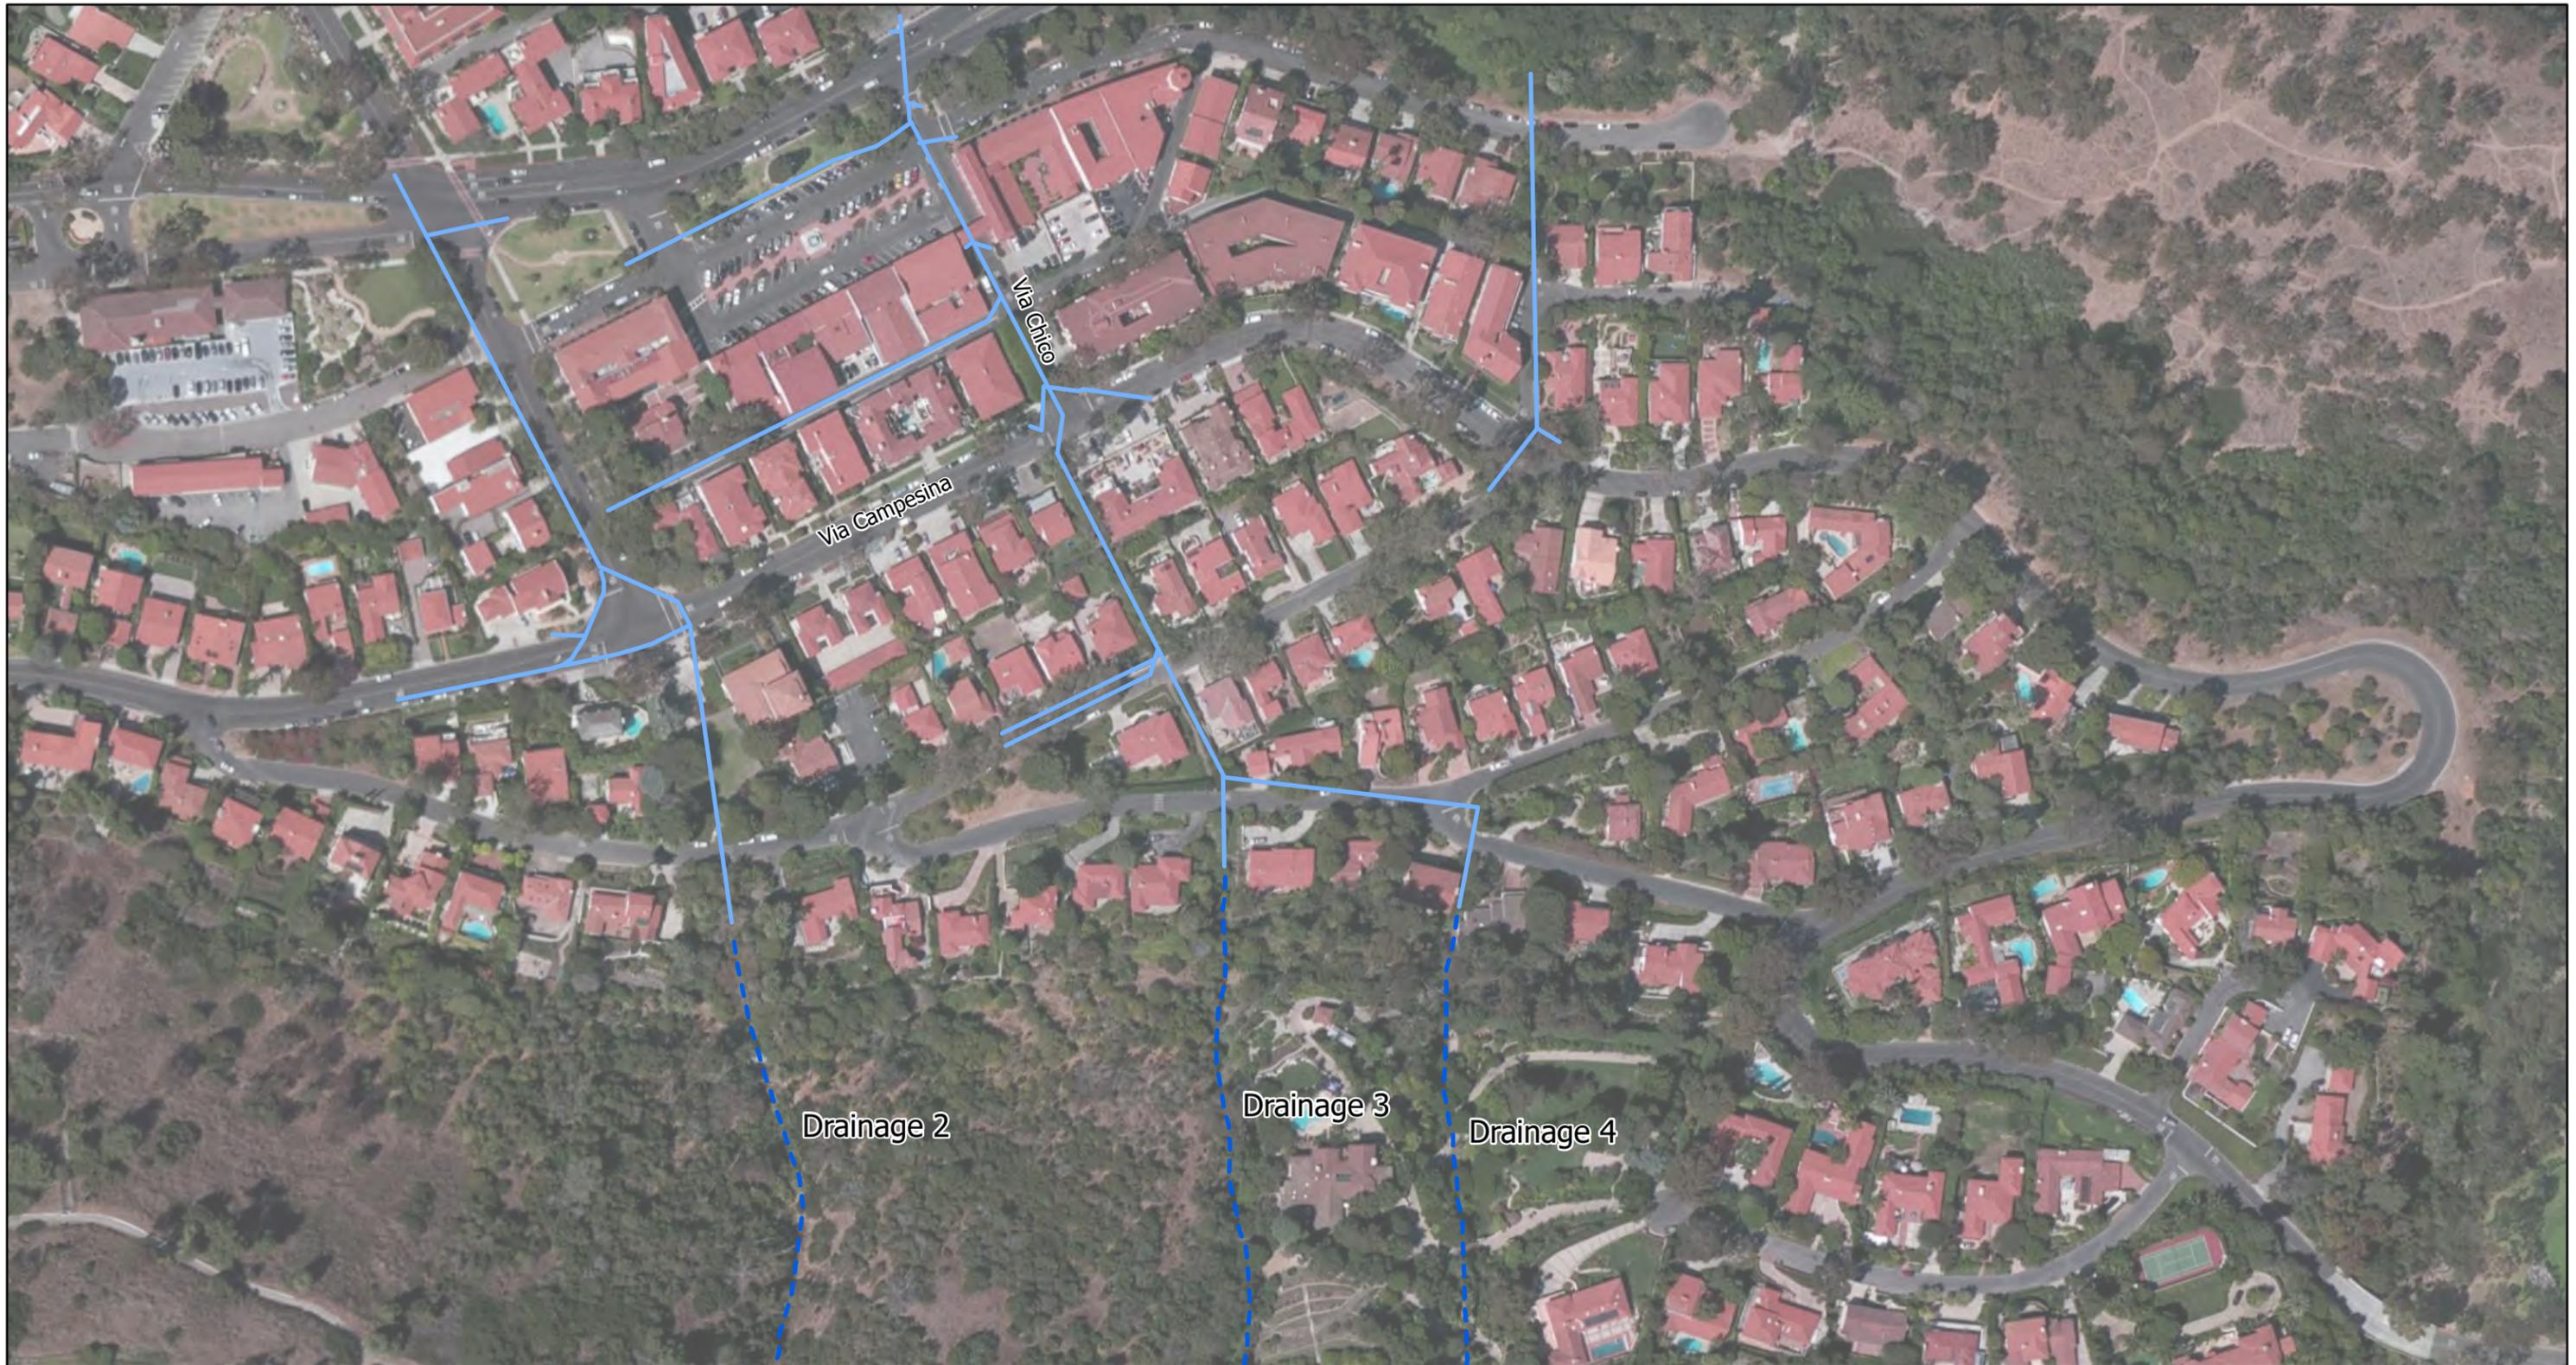
Figure
10

The existing drainage infrastructure around Malaga Cove Plaza was reviewed using available public data and GIS data provided by the City (Figure 10). Storm drains run parallel to Via Corta and Via Chico, following the down-gradient elevation paths of Drainages 2 and 3, as previously discussed in Section 2.2, and cross Via Campesina.

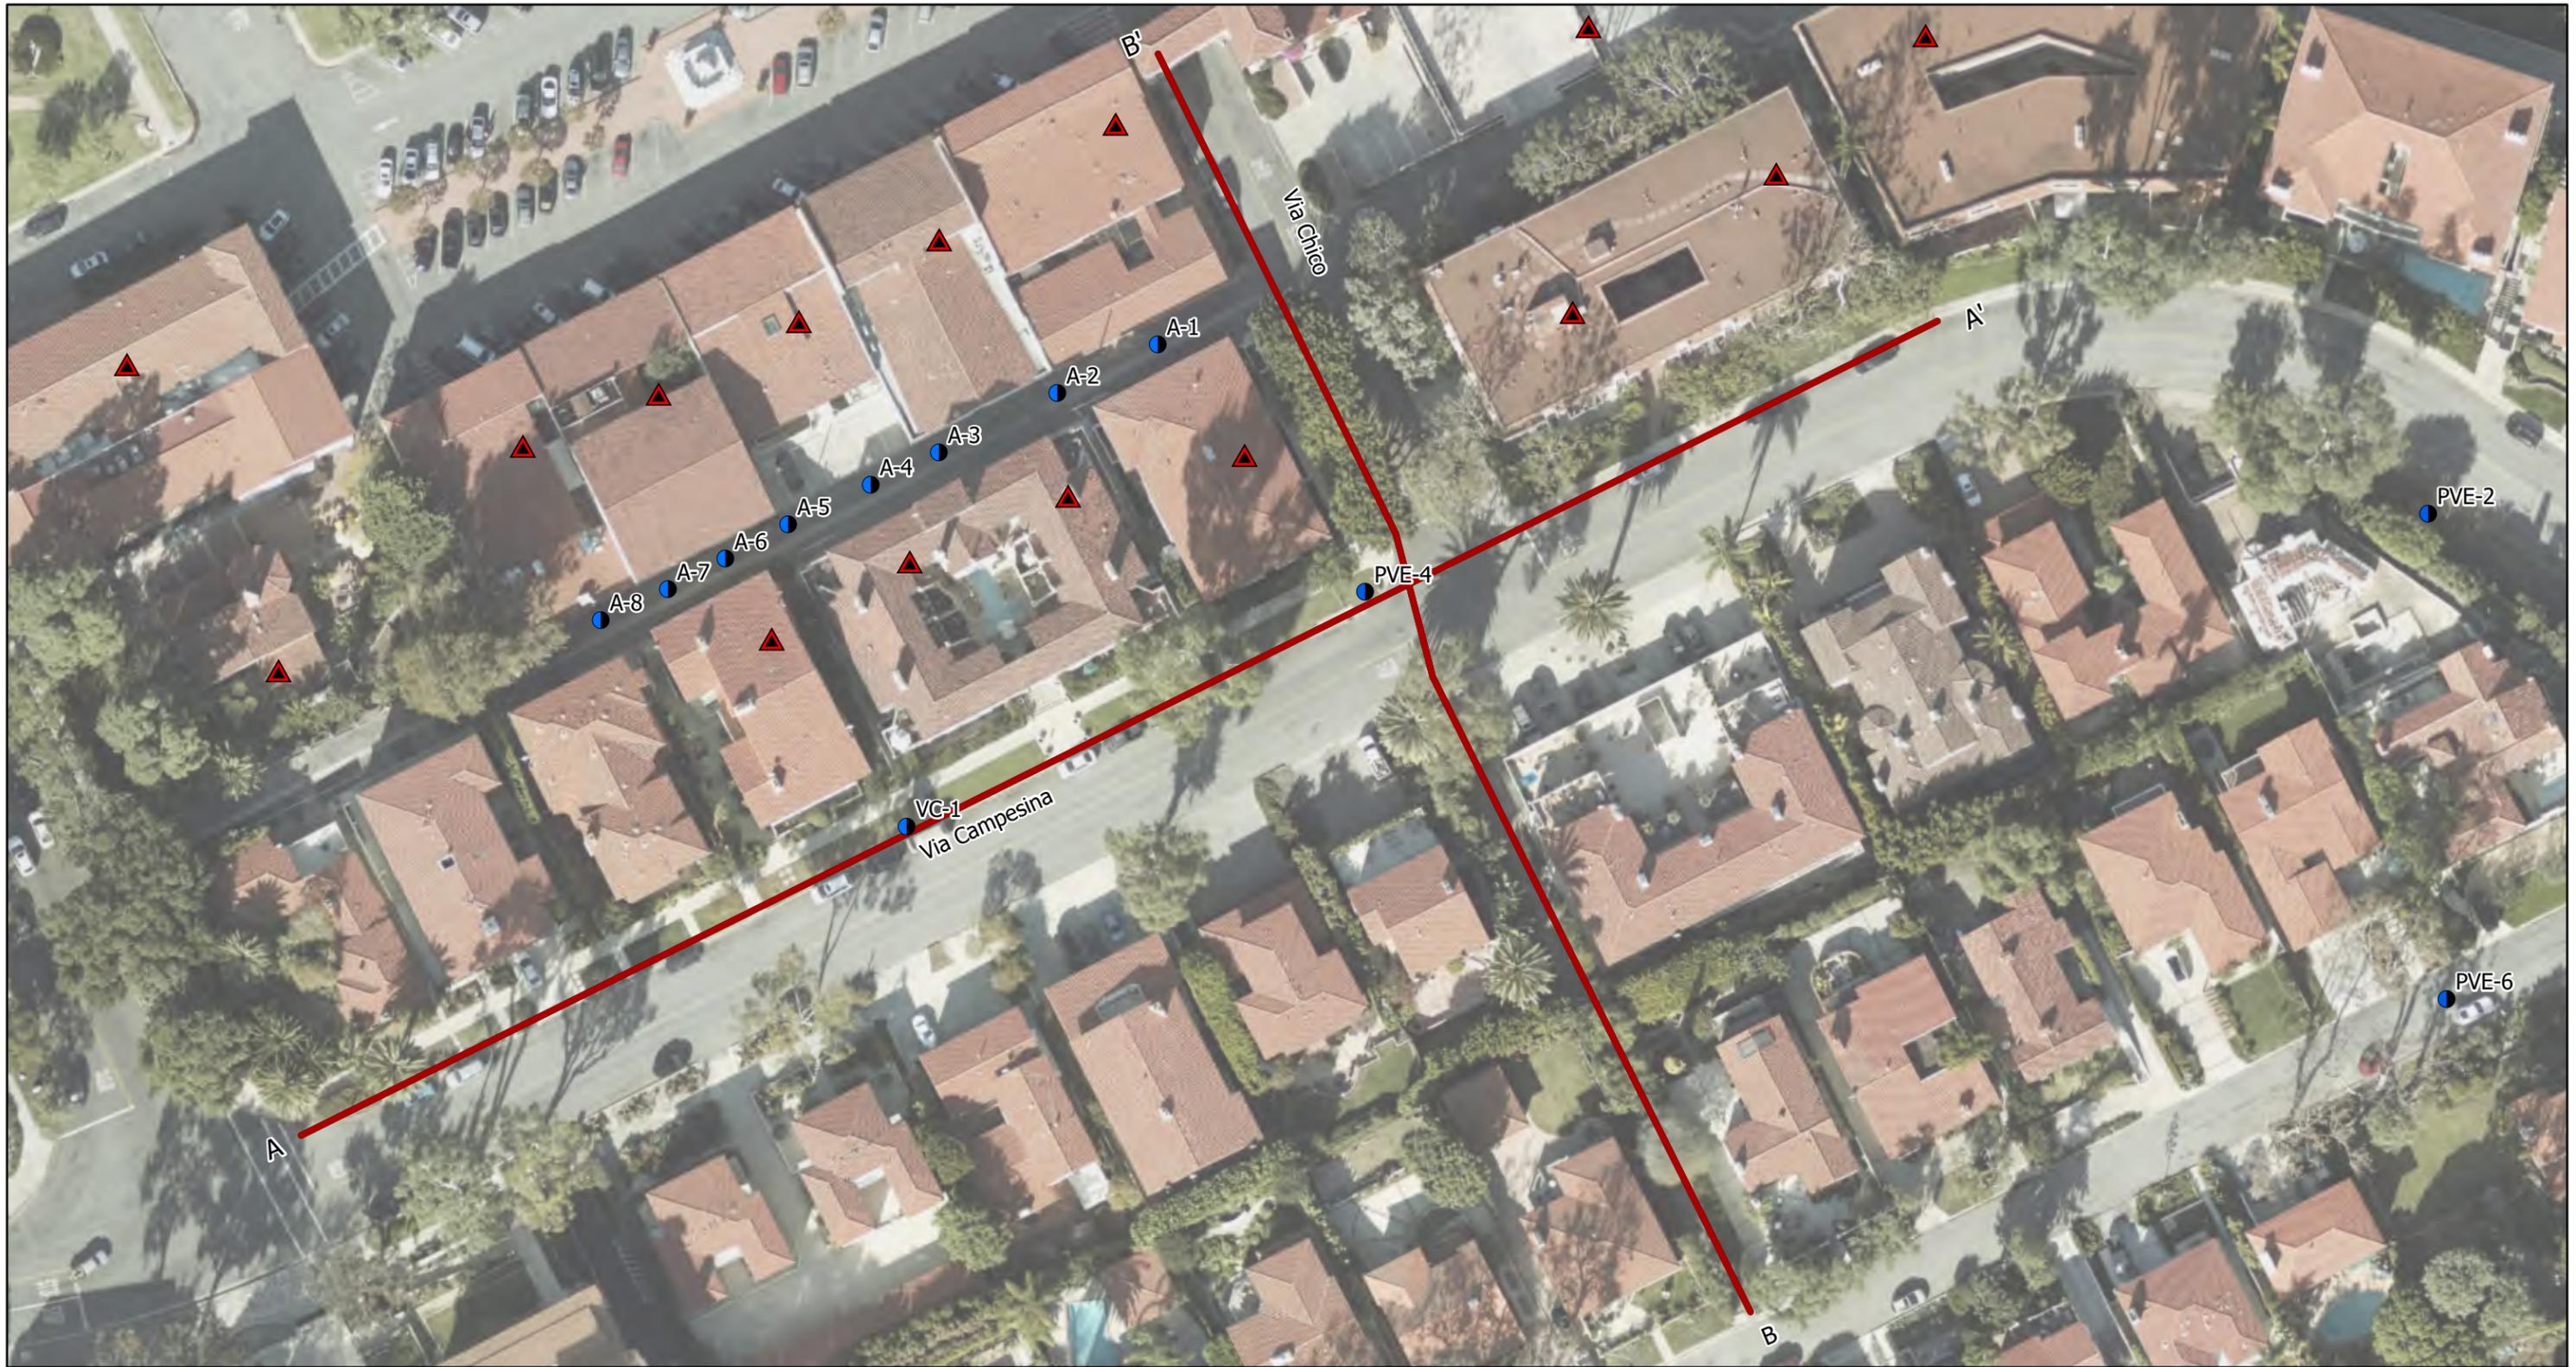
<p>Geophysical Electrical Resistivity Transect Locations</p> <p>Malaga Cove Plaza Area Palos Verdes Estates, CA</p>	
<p>Geosyntec consultants</p>	<p>Figure 14</p>
<p>SC1425</p>	<p>June 2024</p>

As discussed in Section 2.10.1, the extent and depth of preferential pathways, such as dune sand units, were not well known. Therefore, additional data collection was necessary to delineate these pathways. To address this, Geosyntec proposed conducting a surface geophysical resistivity survey to characterize the complex geology along Via Chico/Chico Path and Via Campesina near Malaga Cove Plaza (Figure 14).

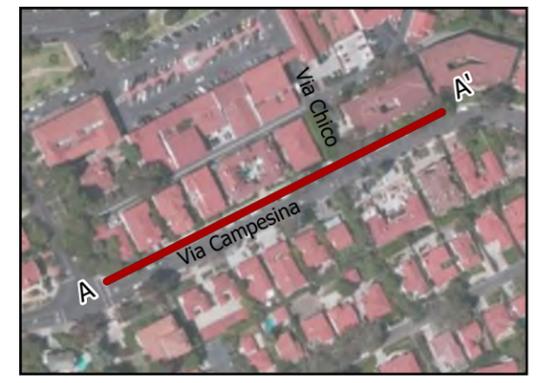
Geophysical Electrical Resistivity Cross Section A-A' along Via Campesina Malaga Cove Plaza Area Palos Verdes Estates, CA	
SC1425	June 2024
Figure 15

The resistivity profile for A-A' is shown on Figure 15. The horizontal axis represents ground distance (Station) in feet along the line, and the vertical axis represents MSL elevations in feet. The data collected along A-A' were noisier due to the presence of numerous metallic or conductive utilities, particularly steel or steel-reinforced storm drain lines, storm drain vaults, and steel water lines. These features caused noisy and erroneous data points at depth and at the northeast end of A-A'. Surface features, tie points, and key interpreted geologic and hydrogeologic units are labeled on the profile on Figure 15.

The southern-southwestern boundary of the fault block is indicated by a heavy dashed black line on Figure 15, approximately at Station 420 on A-A'. Northeast of Station 420, the contact with the Valmonte Diatomite unit is identified by a high resistivity anomaly (300 to 3,000 Ohm-meters) occurring at about 69 feet bgs (171 feet MSL). This contact rises roughly 20 feet in elevation beneath Via Chico around Station 480.

The depth to groundwater along A-A' was interpreted using resistivity data, correlations with known groundwater depths in wells PVE-4 and VC-1, and field observations of water in vaults and catch basins. The approximate groundwater depth between VC-1 and the north end of the fault block is shown with a dashed pink line on Figure 15. In areas with extensive utility interference, such as between Stations 420 and 590, the groundwater contact is interpolated and smoothed between "clean" data points, indicated by low resistivity values (darkest blue to deep blue). Utility interference typically appears as higher resistivity values, such as those from a metallic storm drain vault and reinforced concrete storm drain between Stations 535 and 570, labeled on Figure 15.

An area where deeper groundwater rises to the surface or near-surface levels (e.g., upwelling) of conductive groundwater southwest of the fault block is evident between Stations 250 and 300. This is shown by a 15-foot-thick layer of very low resistivity values (0.3 to 2 Ohm-meters, darkest blue) over a vertically oriented highly resistive feature (dark red) at about 35 feet bgs at Station 275. This low resistivity layer could correspond to conductive groundwater upwelling around a resistive/impermeable nodule, based on groundwater data from well VC-1. However, a metallic storm drain lateral may also be present, as labeled in Figure 15. The apparent perched groundwater contact is indicated with a dashed pink line, ranging from 10 feet (high point at Station 275) to 32 feet bgs between Stations 250 and 300.
