Re: Property Condition Assessment Report for *Palos Verdes Estates City Hall Buildings and Parking Structure and Seismic Evaluation Palos Verdes Estates, California 90274 Walker Consultants Project No. 37-009696.01*

## Property Condition Assessment Report

Palos Verdes Estates City Hall  
Buildings and Parking Structure and Seismic Evaluation  
Palos Verdes Estates, California  
Walker Project No. 37-009696.01  
November 30, 2023

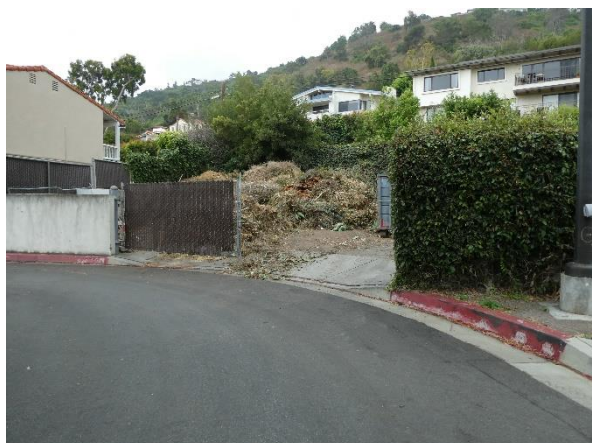
Photo 6 - Remote Lot: Dumpster area near the Remote Lot.

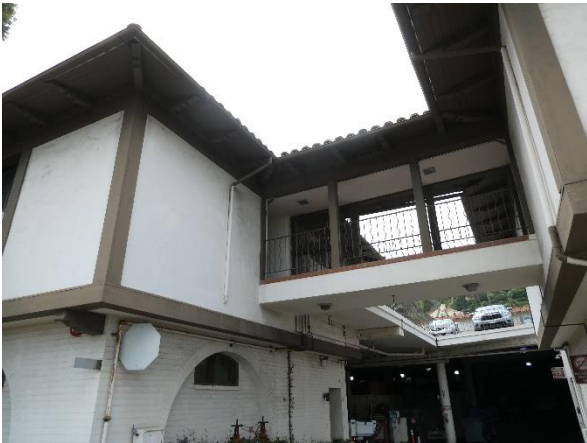
Photo 39 - Elevated walkway.

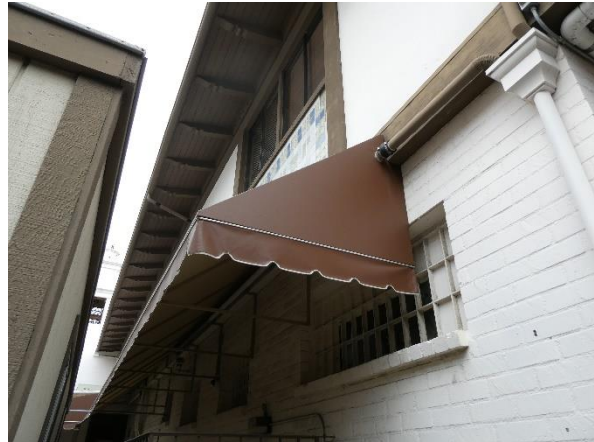
Photo 50 - Building 340: Vinyl-wrapped, metal-framed awning at the South building elevation.

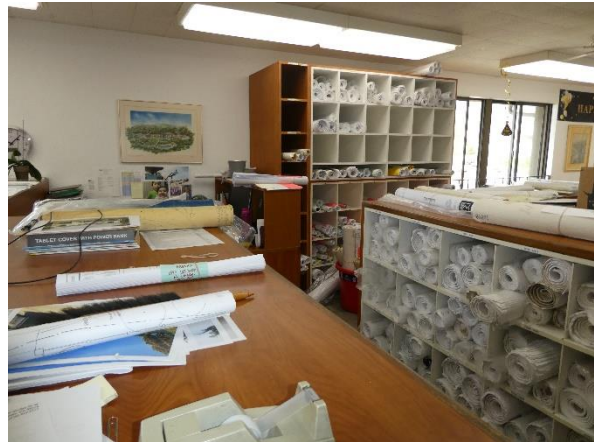
Photo 91 - Building 320: office finishes.

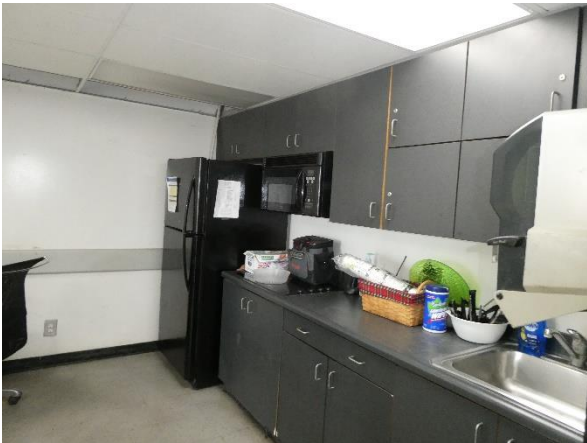
Photo 98 - Building 320 (Maintenance Department): Break  
room.

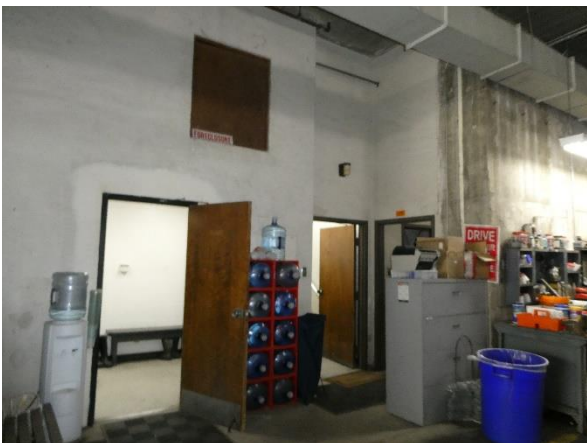
Photo 106 - Garage finishes.

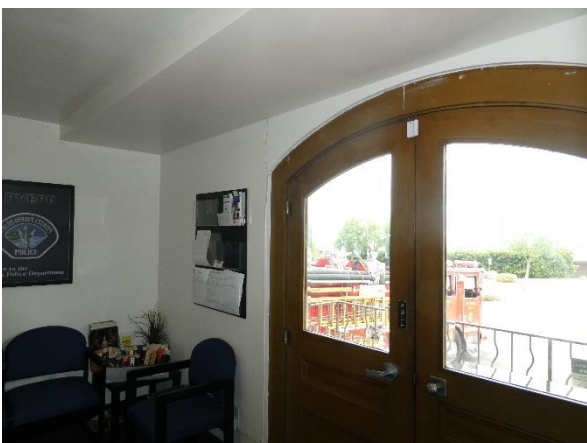
Photo 112 - Freestanding building interior finishes.

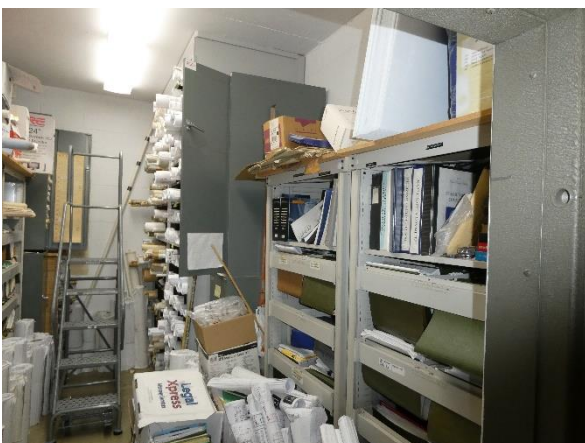
Photo 130 - Building 340 (City Hall): Office.
